MEMORANDUM

To: Paul Kolp, Lower Columbia Estuary Partnership
From: Gardner Johnston, Josh Epstein, and Mike Rafferty (Inter-Fluve)
Date: February 8, 2024
Project: Ridgefield Pits Restoration
Re: Subsurface Investigations

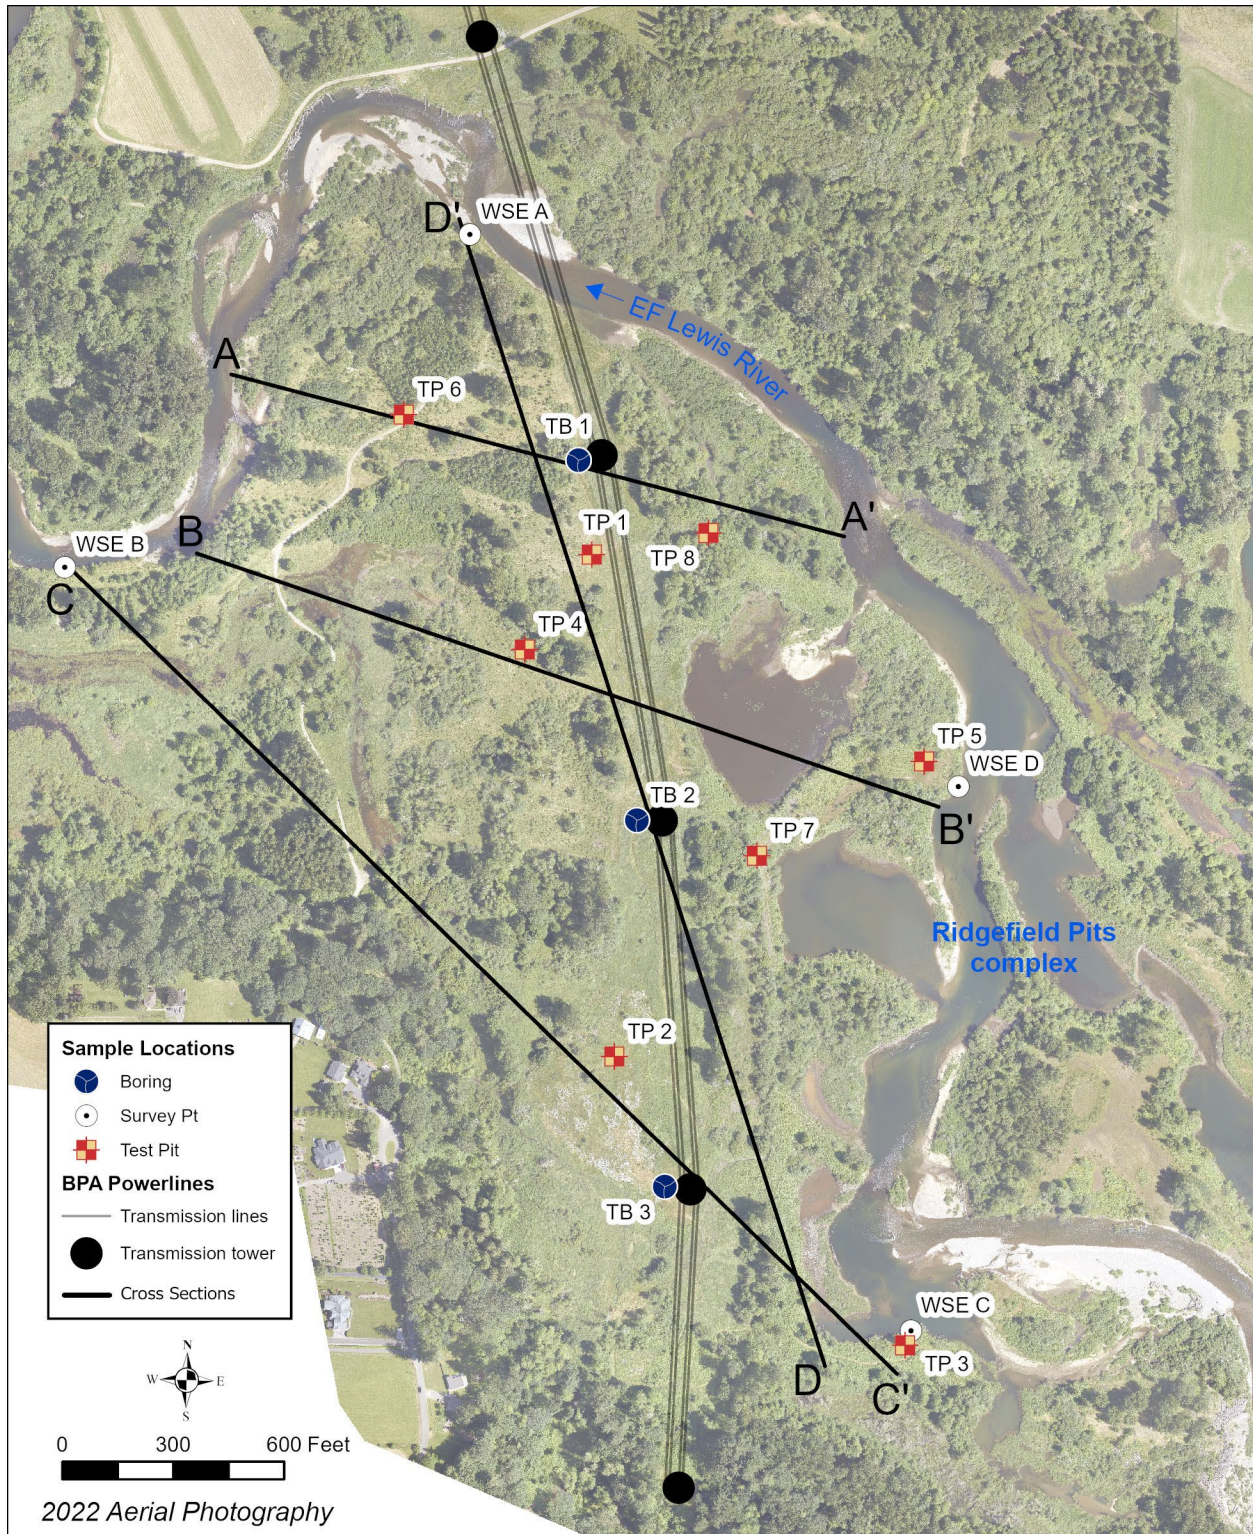
Figure 4. Location of cross-sections used for visualization of subsurface and WSE data for the West Floodplain area. East floodplain cross sections and profile are shown in Figure 2.

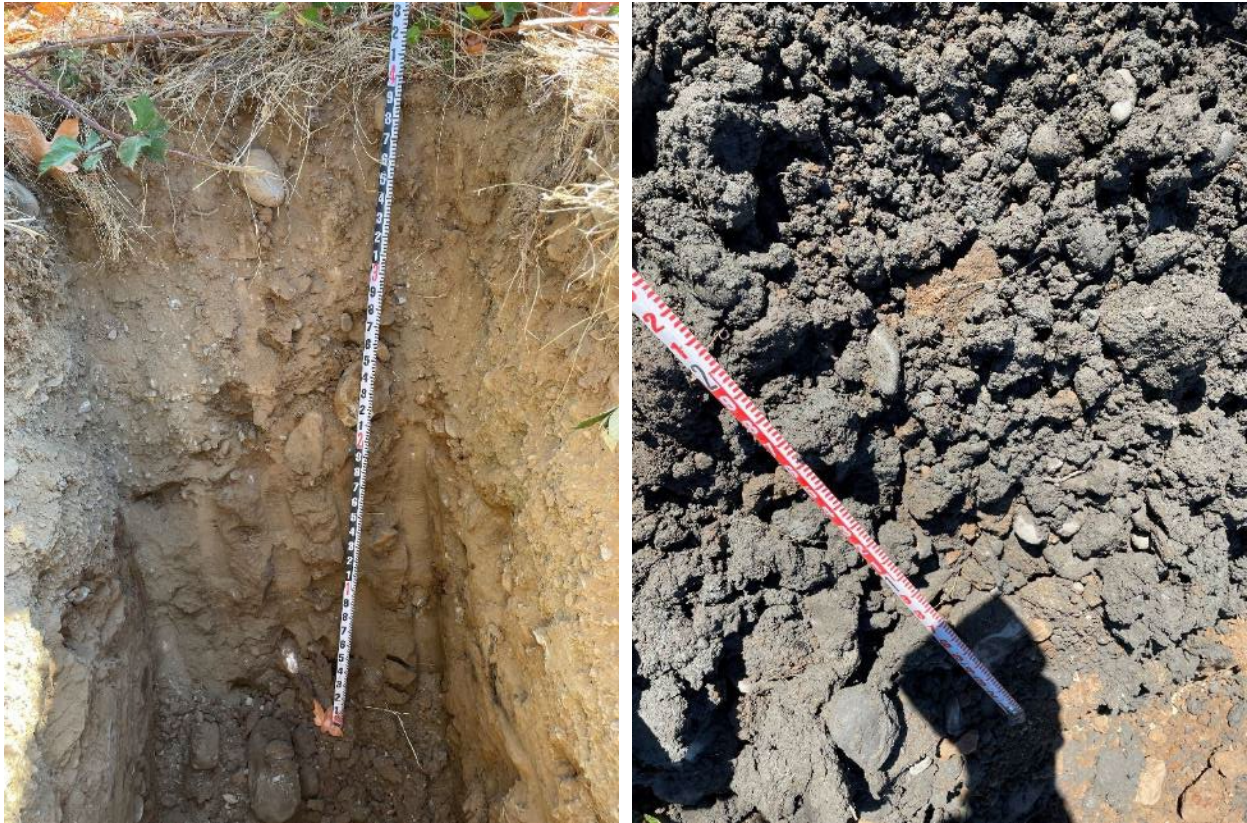
West Test Pit 3 Photos

Top left – disturbed fill layers in top 4 feet. Top right – Material below 5.5 feet depth comprised of sandy silt with gravels. Bottom – spoils pile mostly showing deeper sandy silt and clay loam layer, some gravels and cobbles up to 6 inches diameter.

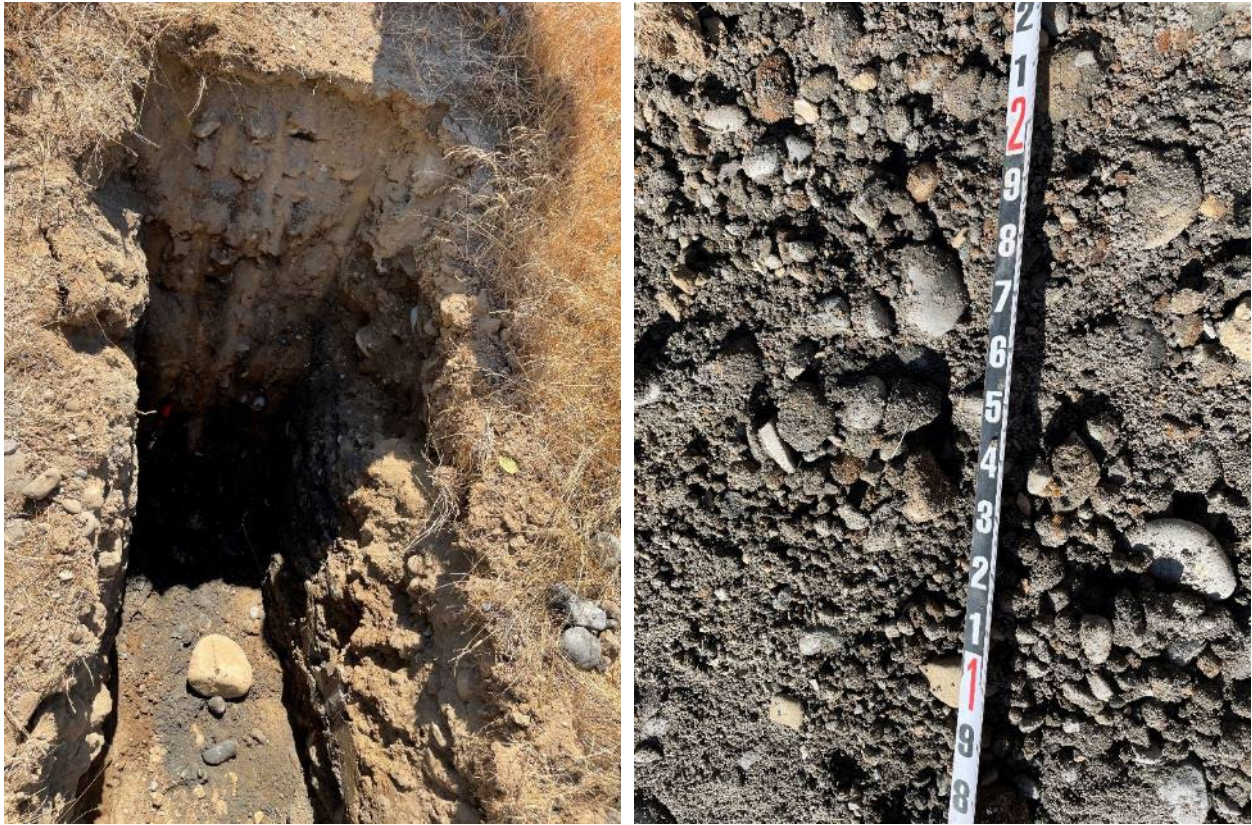
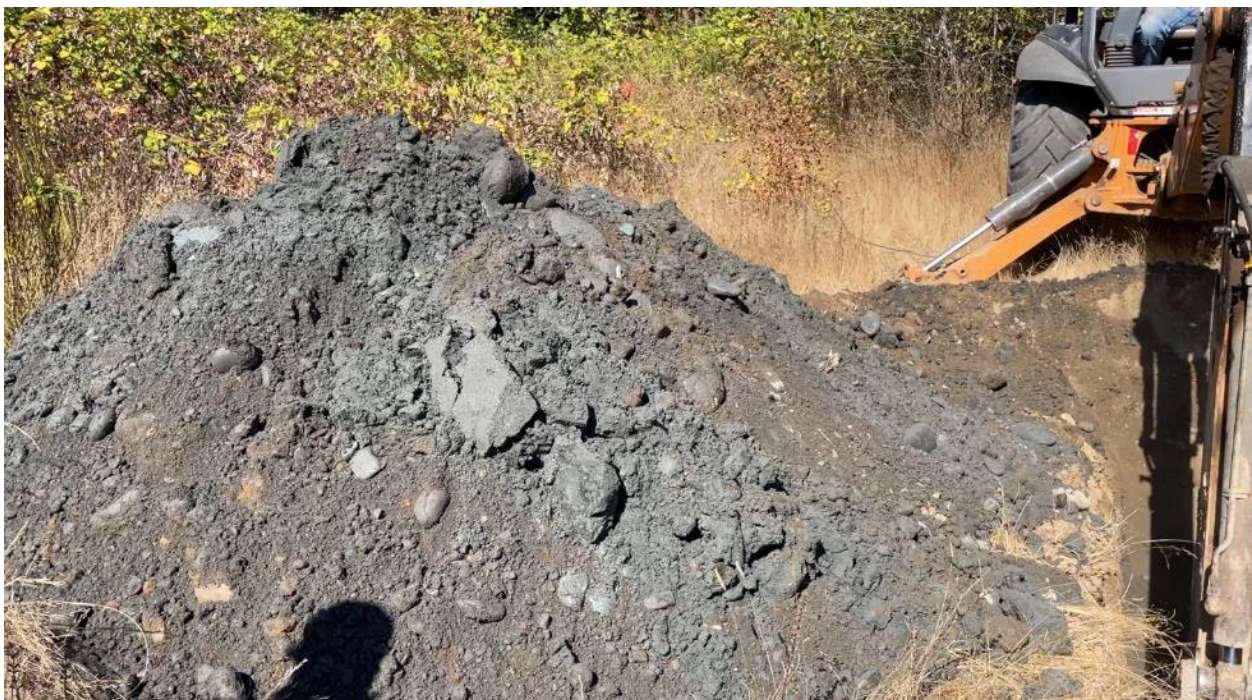
West Test Pit 5 Photos

Top left – top disturbed layers (top 7 ft) with approximately 50% gravel or larger. Top right – material below 7 ft depth comprised of silty sand with approximately 30% gravel or larger. Bottom – spoils pile showing mainly the gray gravelly silt from 2 to 7 ft depth.

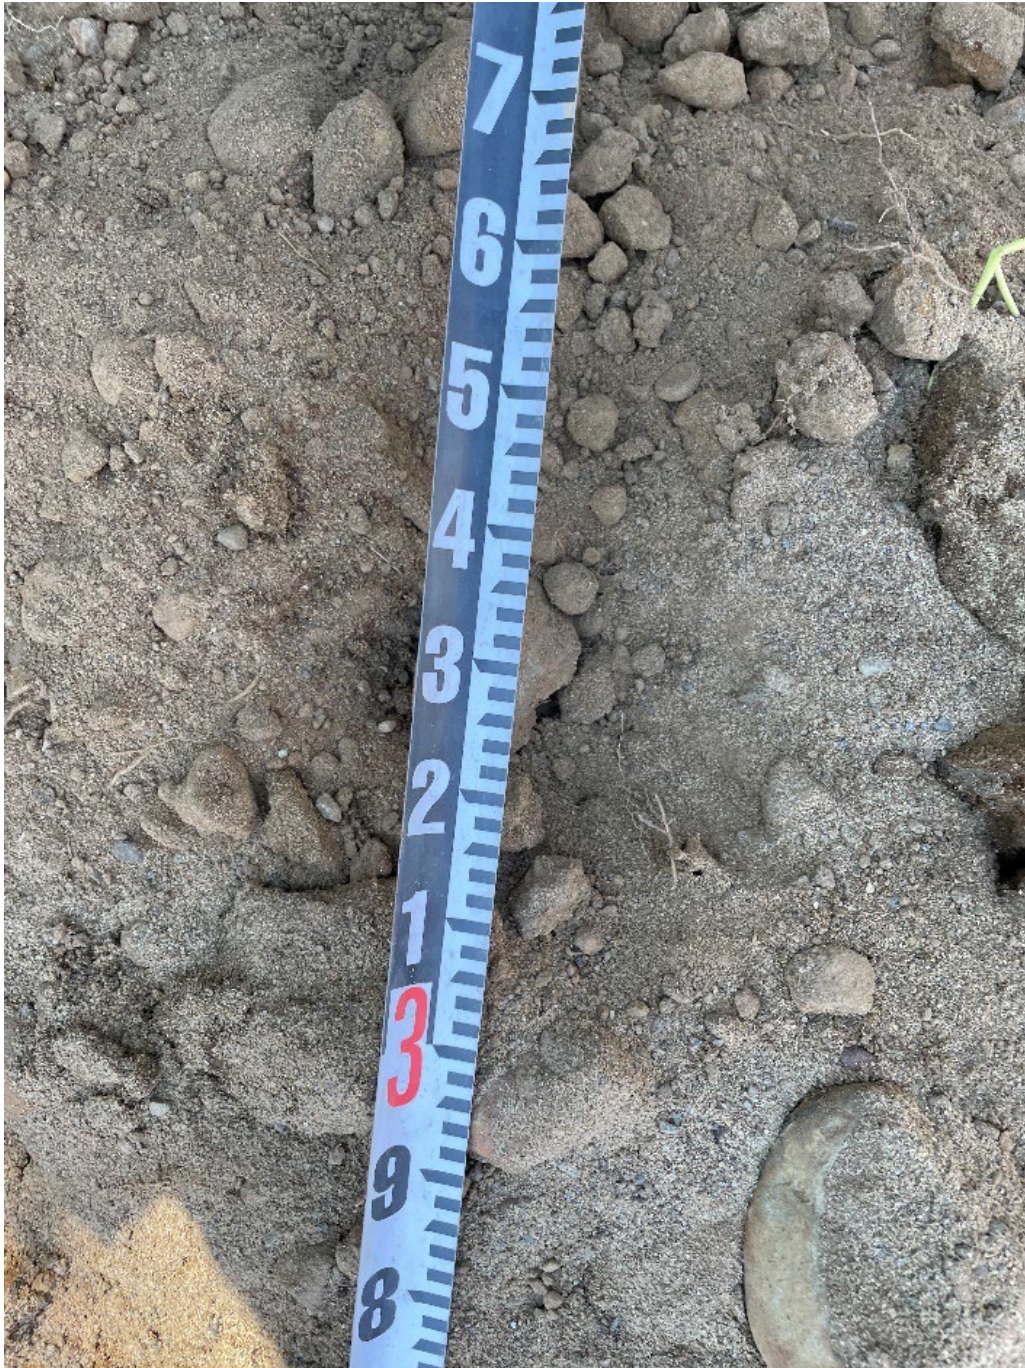
West Test Pit 7 Photo

Top 3 feet of Test Pit 7 (sand with approximately 20% gravel or larger)

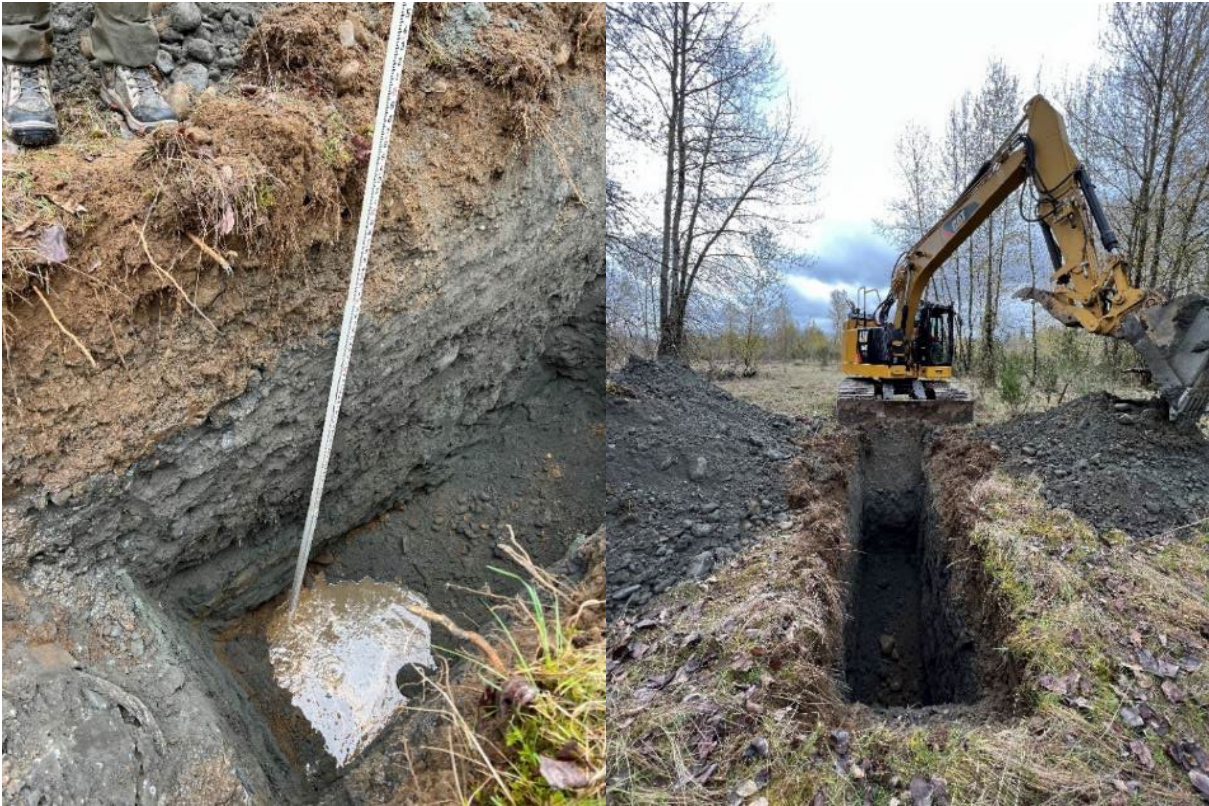
East – Test Pit 10 Photos

Left - Clear transition from brown fines to gray clay layer.

Right – Spoils piles show gravel and cobbles from the bottom of the pit.

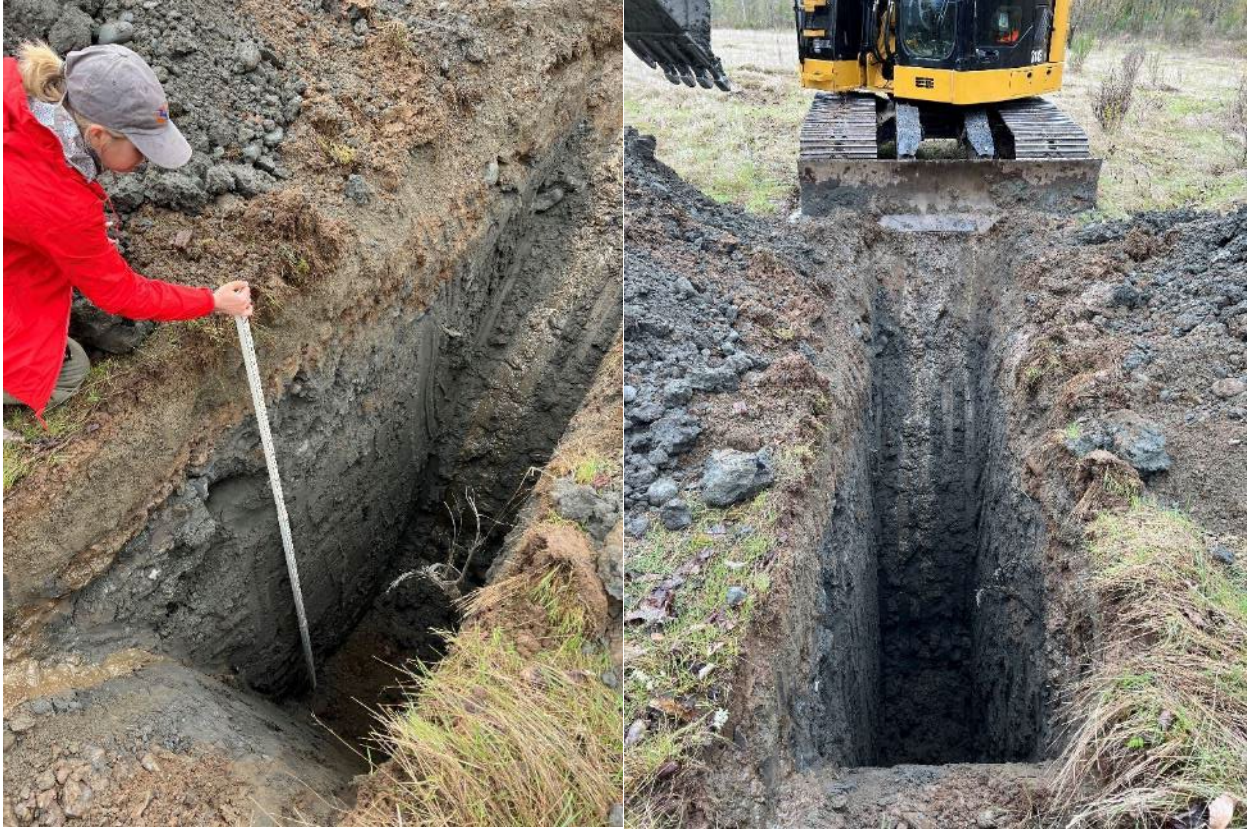
East – Test Pit 11 Photos

Left – Clear soil horizons, transitions from brown fines and silt to gray clay.

Right – Clay layer extends to the bottom of the 13 ft deep pit.

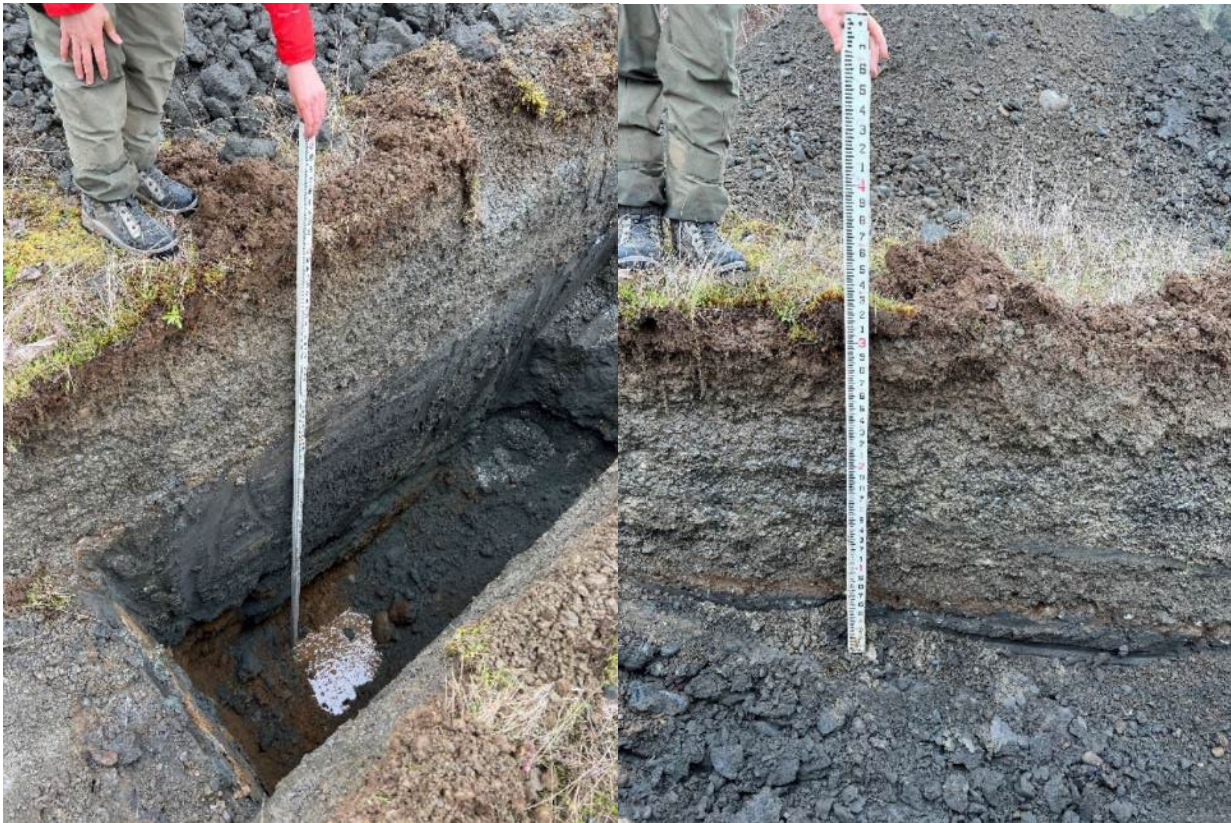
East – Test Pit 12 Photos

Left – Clear soil horizons; Brown silty soil above gray sand above gray clay.

Right – Close up of soil horizons

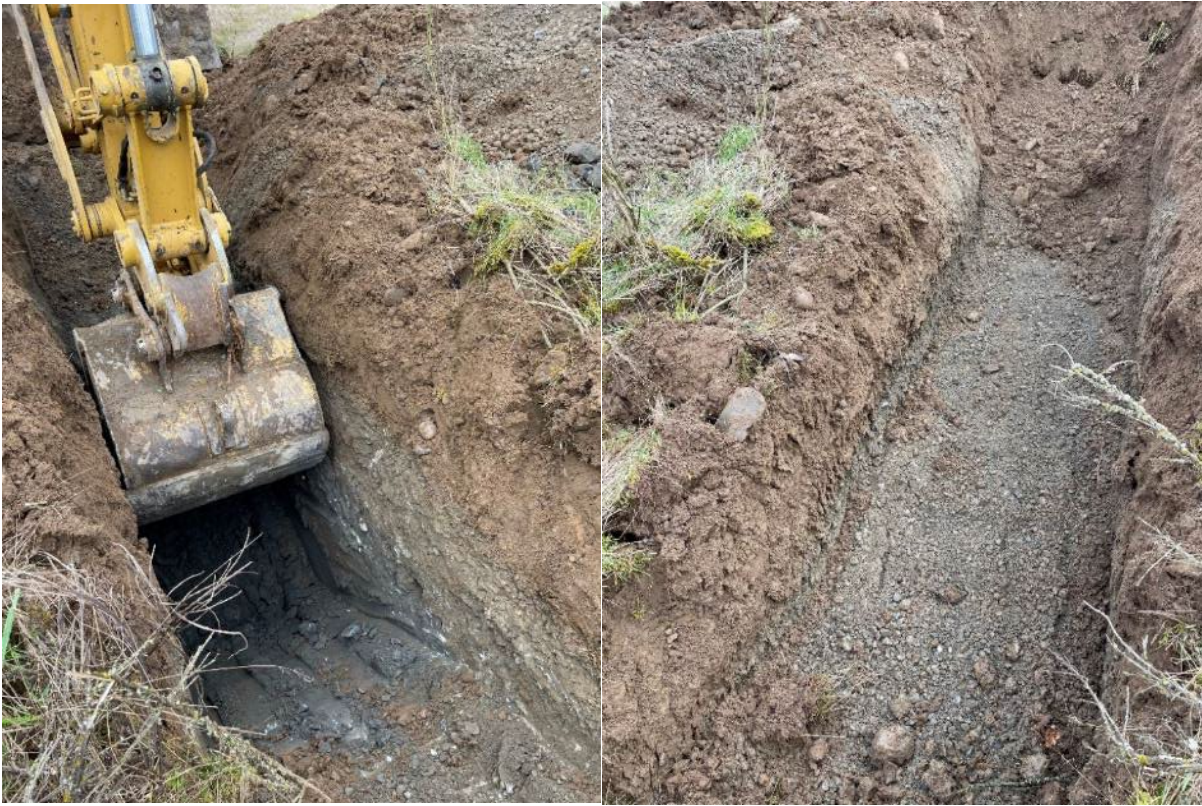
East – Test Pit 13 Photos

Left – Brown fines mix with some gravel above gray sand. Below gray sand is a layer of gray clay.

Right – Unconsolidated gray gravel on the bottom of the pit

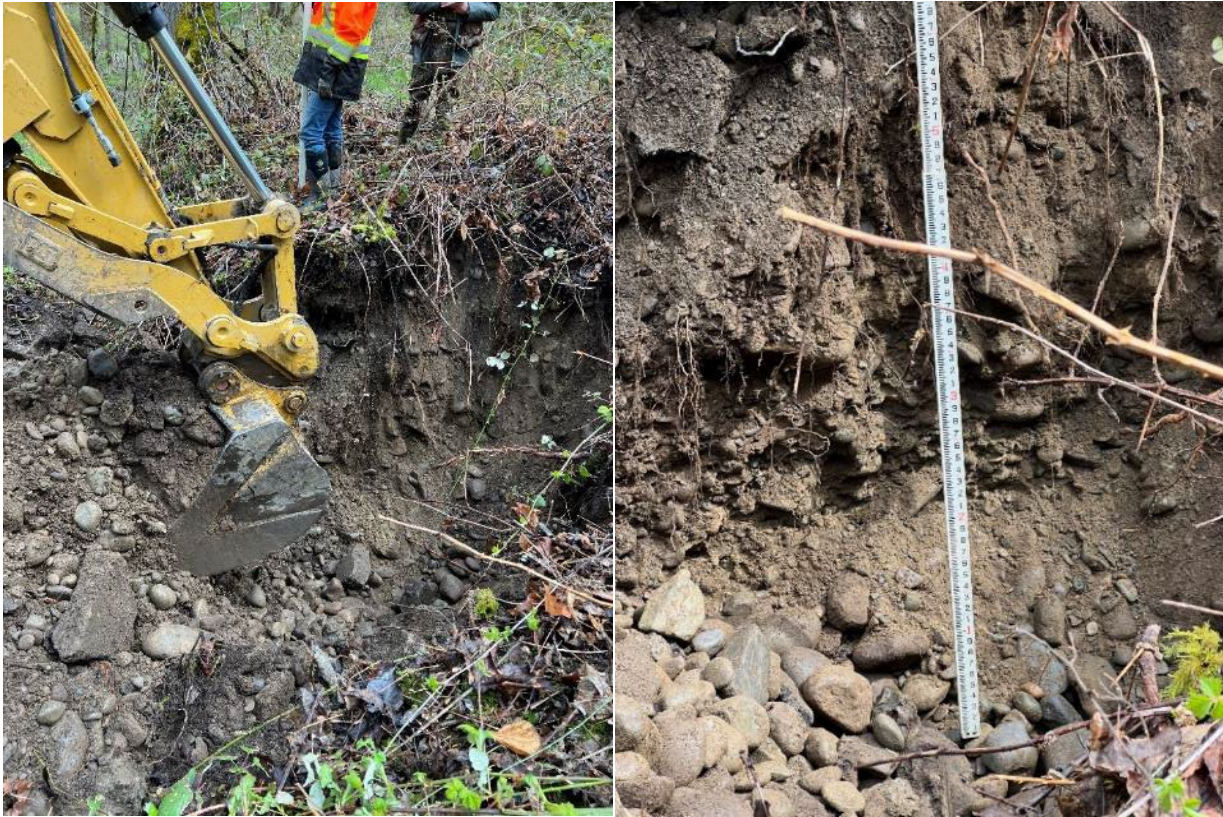
East – Test Dig A Photos

Left – Large chunks of concrete and cobbles in disturbed layer.

Right – Gravel in fine sandy matrix.

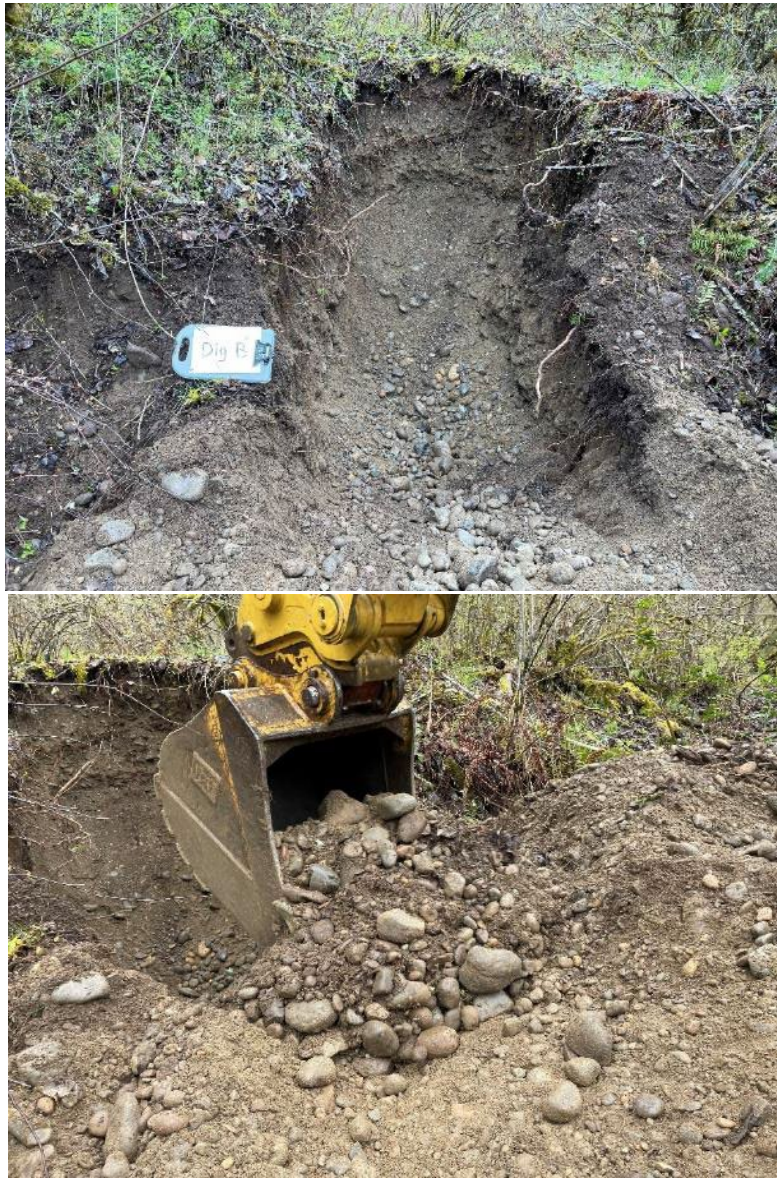
East – Test Dig B Photos

Top – Gravel mixing into loose fines.

Bottom – Large, rounded cobbles and gravel from the bottom of the pit.

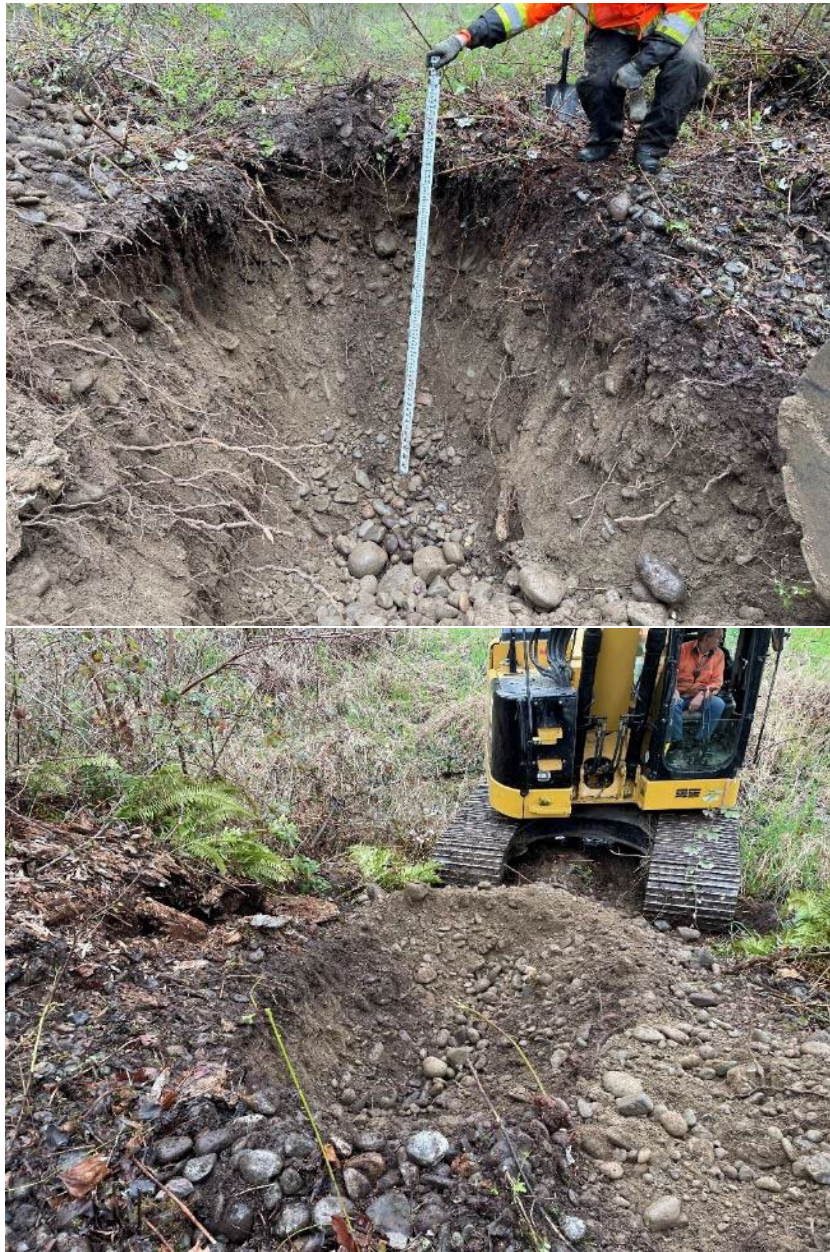
East – Test Dig C Photos

Left – Gravel and cobbles in an unconsolidated matrix of fines.

Right – Rounded cobbles on the ground surface.

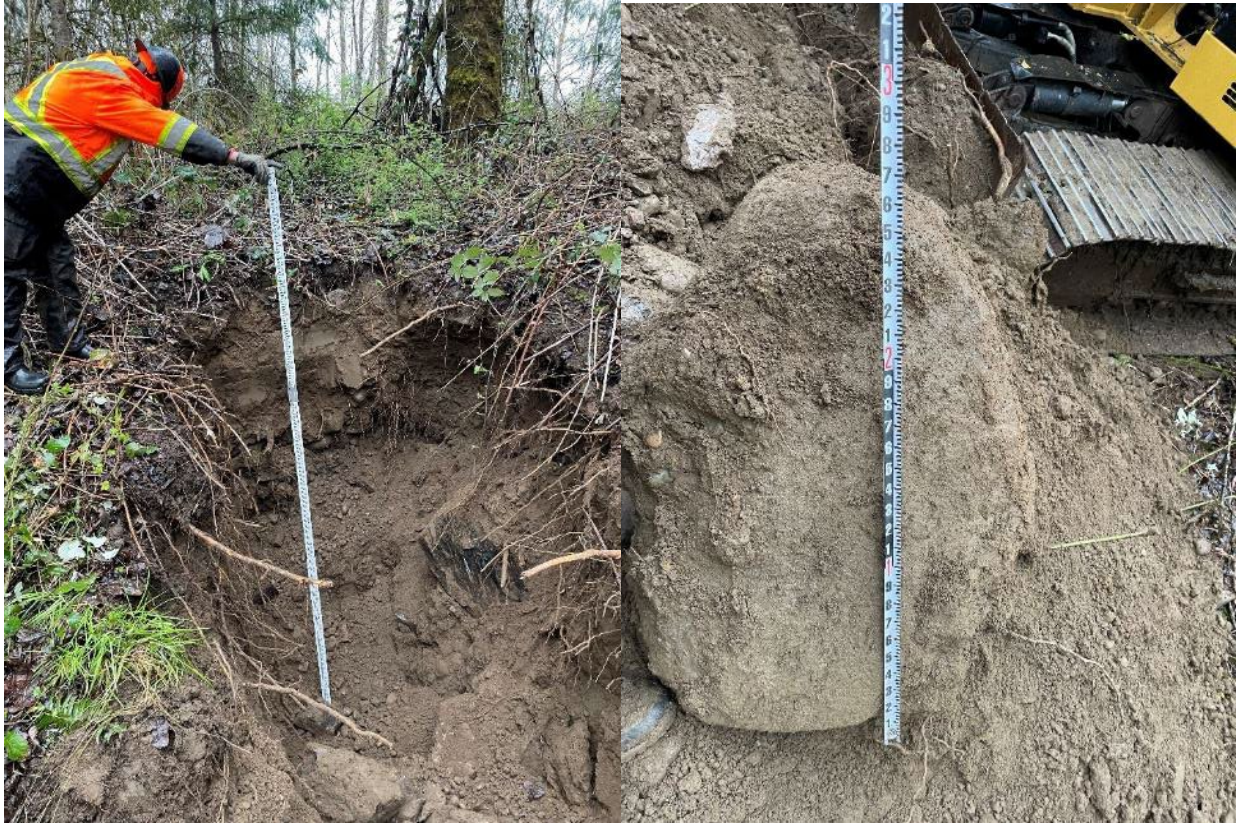
East – Test Dig D1 Photos

Left – Silty sand layer on top of fines and gravel.

Right – ~30 inch cobble from the pit.

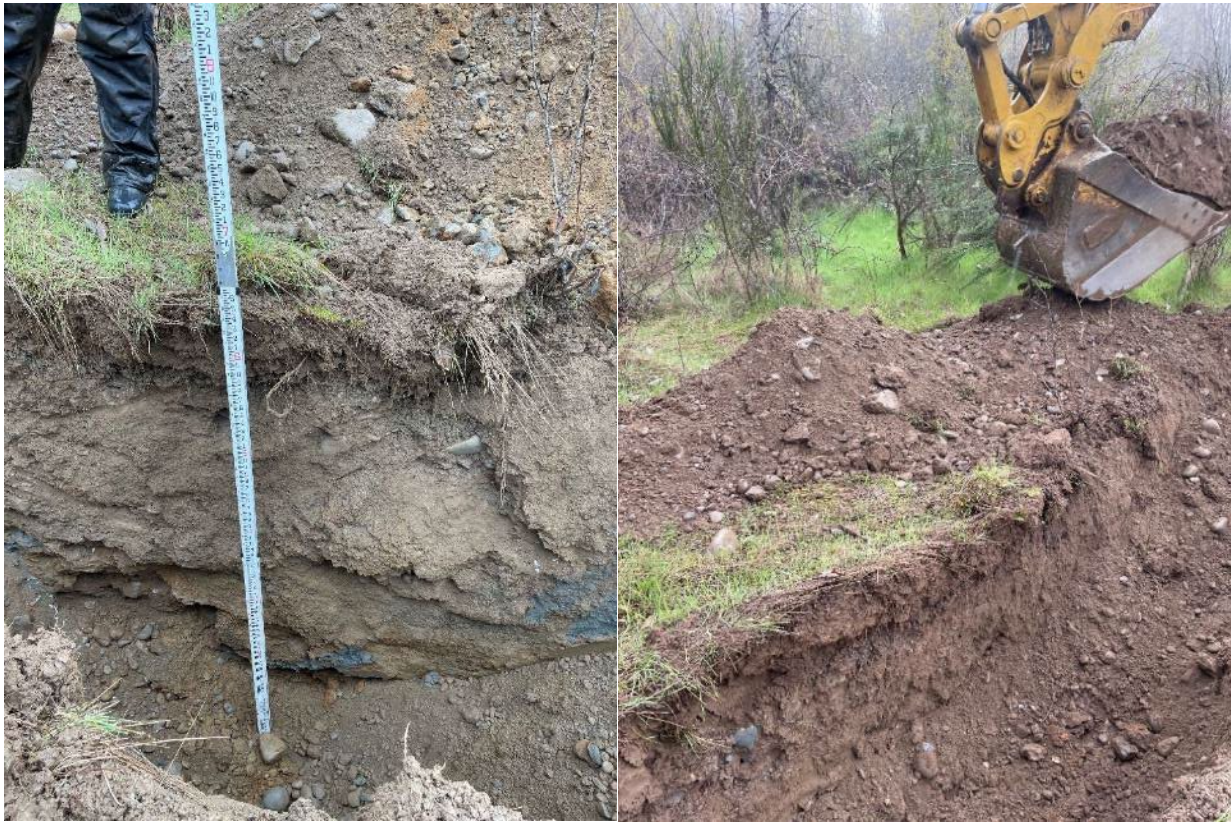
East – Test Dig E Photos

Left - Silty sand above gravel and cobbles layer. Note gray clay mixed into sand layer.

Right – Cobbles and gravel in a fine matrix from the bottom of the pit.

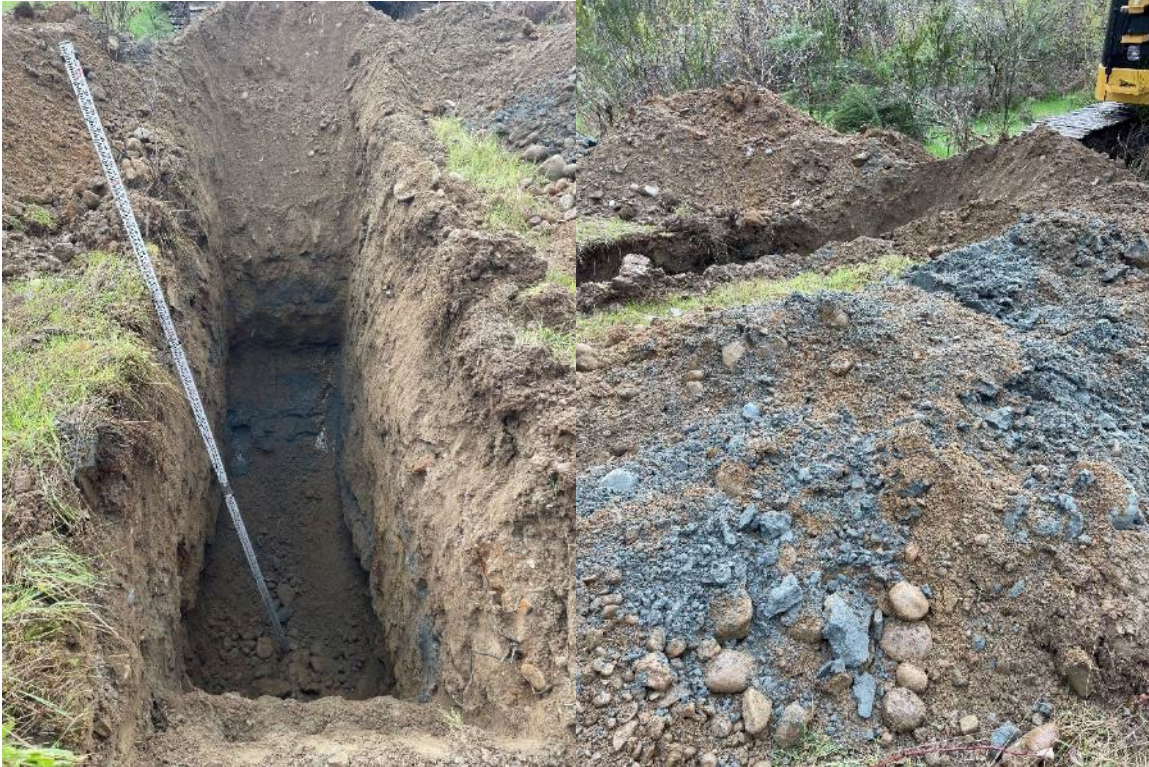
East – Test Dig F Photos

Left – Sand, silt, and cobbles interbedded with gray clay.

Right – Gray clay and cobbles from the bottom of the pit.

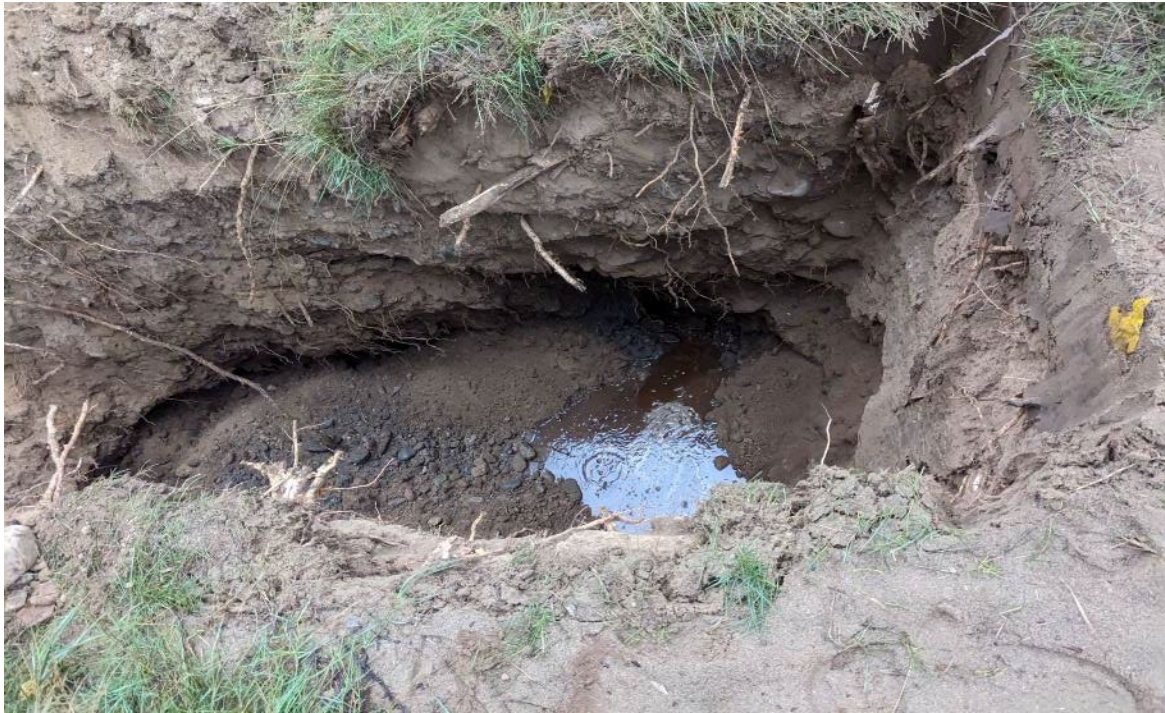
25-2 Photos

Top - test pit with water table at 73 inches; Bottom left - top with thick roots, cobbles and gravels start at 7 inches; Bottom right - >50% coarse materials

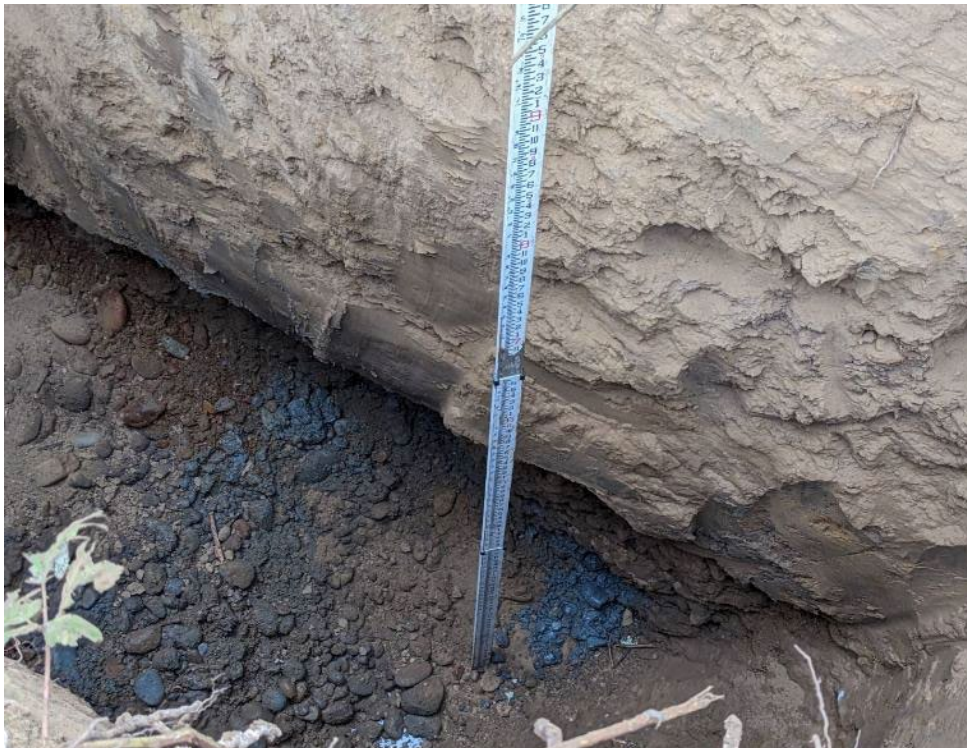
25-3 Photos

Top - thick roots in top few inches, woody debris at 2 feet; Top right - gravels and cobbles with sand from bottom of pit; Bottom - grey silty loam with cobbles in bottom of pit.

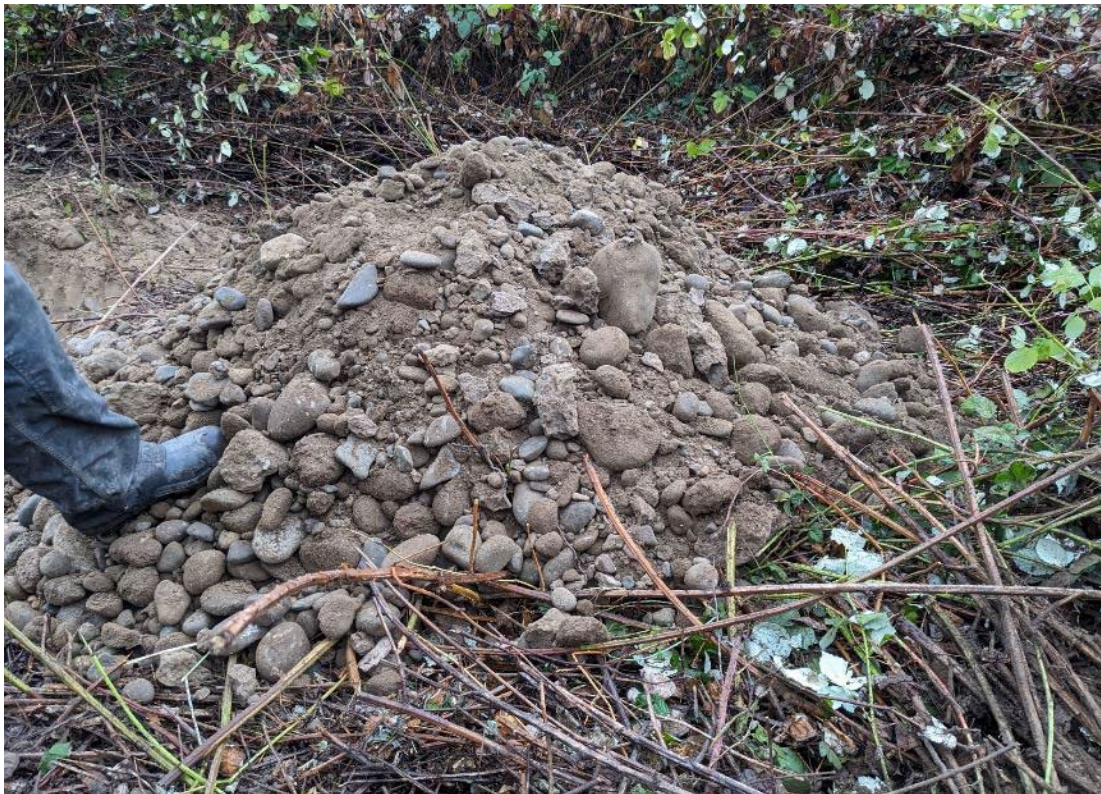
25-4 Photos

Top left - thick tree roots at surface; Top right - Cobbles and gravels at 7 feet; Bottom - larger cobbles with conglomerate material at bottom of test pit

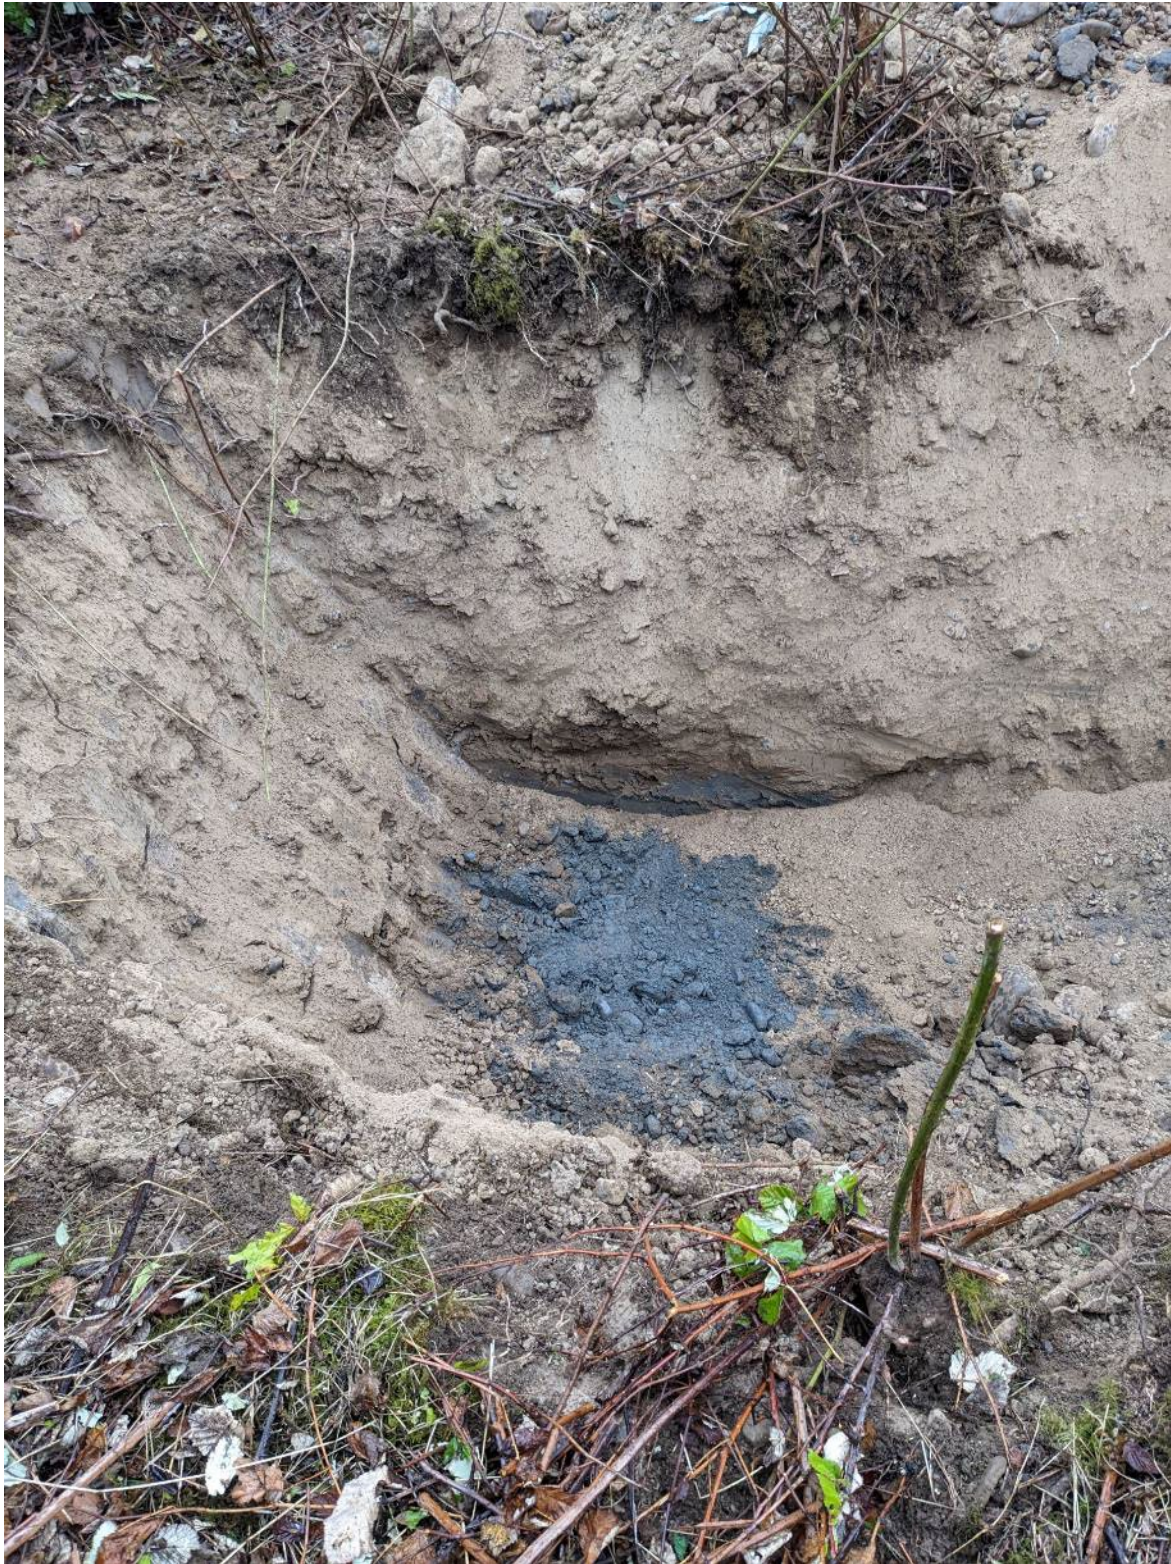
25-5 Photos

Above - Grey / blue sand with soft clay pockets

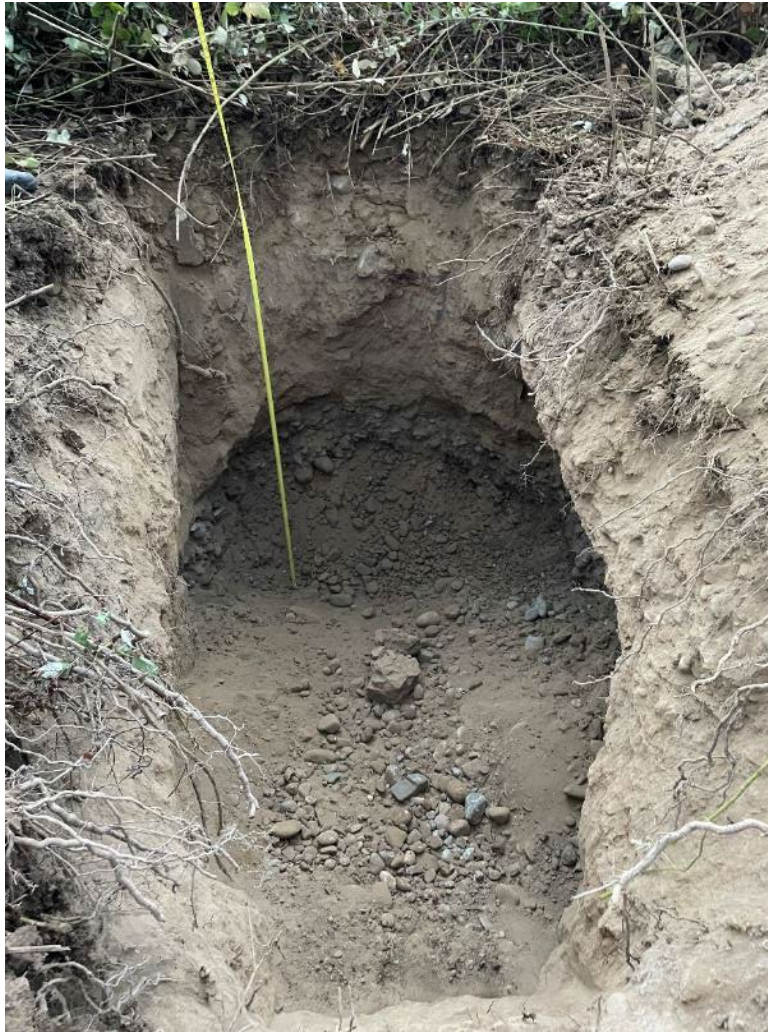
25-7 Photos

Top – coarse layer at 6 foot depth; Bottom – Close-up of coarse alluvial layer

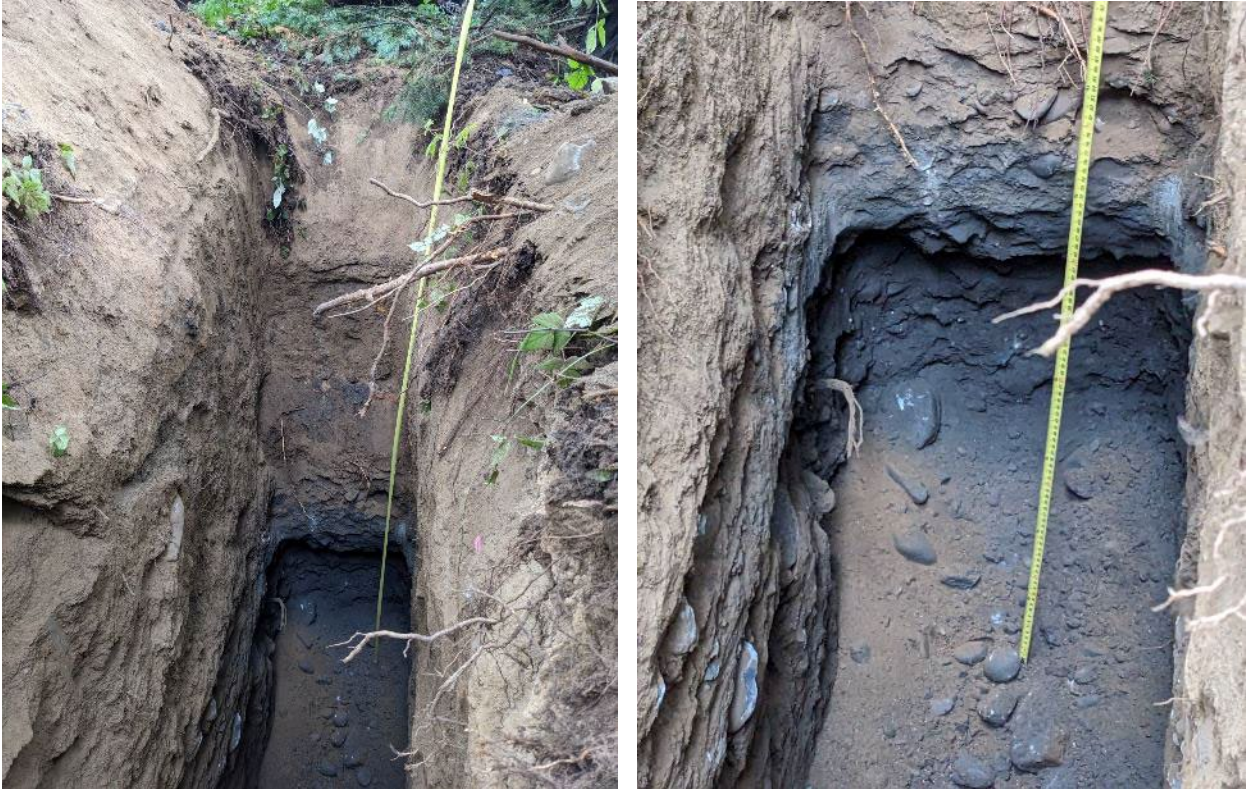
26-1 Photos

Left - Brown silty sand with occasional 10-12 inch cobbles; Right -close up of dark grey material starting at 9 feet, with 10-12 inch cobbles
