MEMORANDUM

To: Paul Kolp, Lower Columbia Estuary Partnership
From: Gardner Johnston, Josh Epstein, and Mike Rafferty (Inter-Fluve)
Date: February 8, 2024
Project: Ridgefield Pits Restoration
Re: Subsurface Investigations

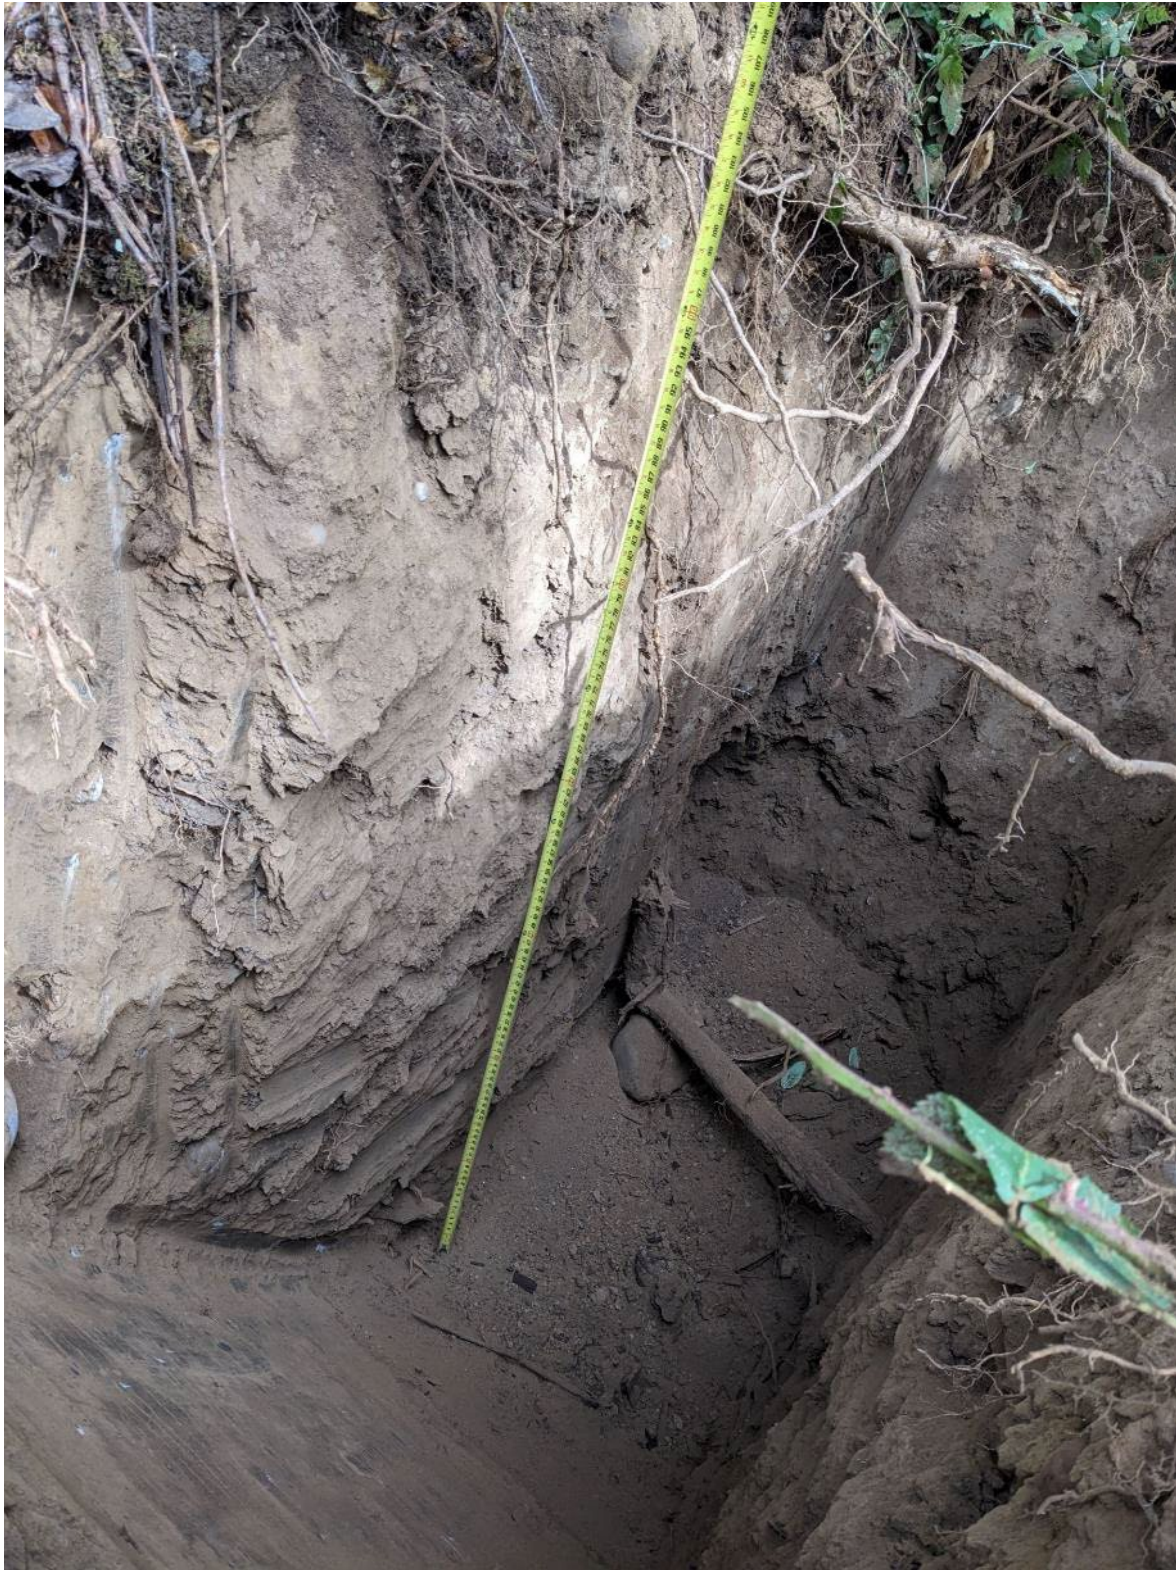
26-7 Photos

Above - Pit taken in berm, silty loam for majority of pit, bottom of pit with woody debris and soils with redox

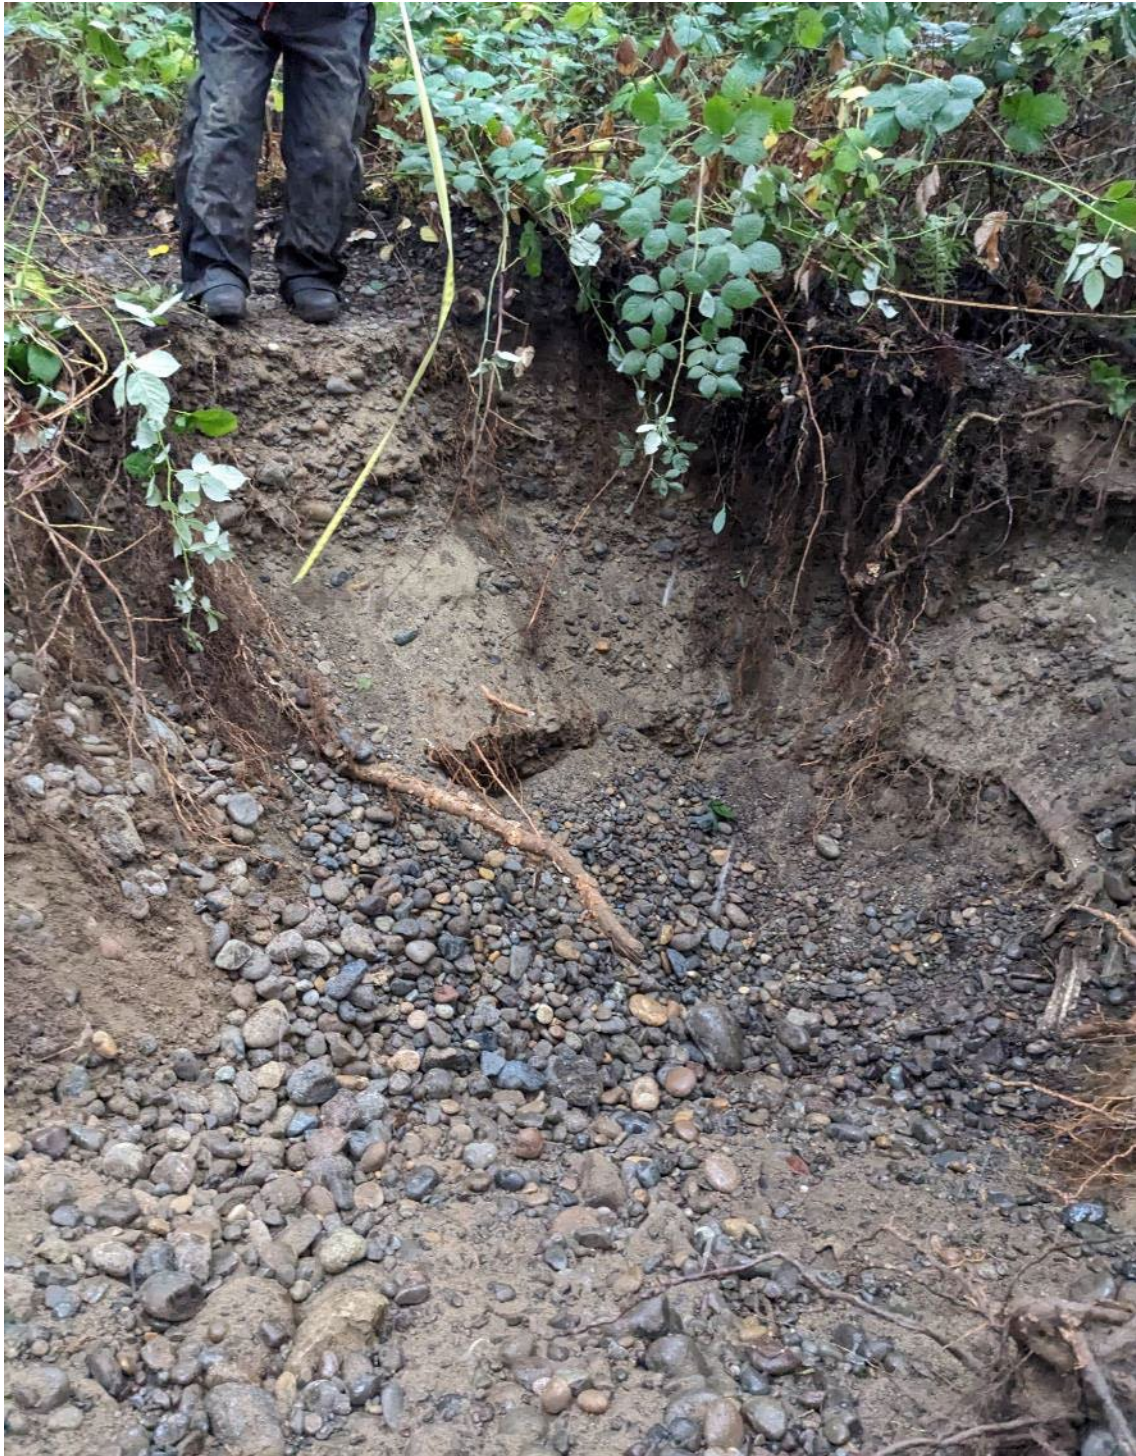
26-8 Photos

Above - Close up of gravels and cobbles in bottom of pit

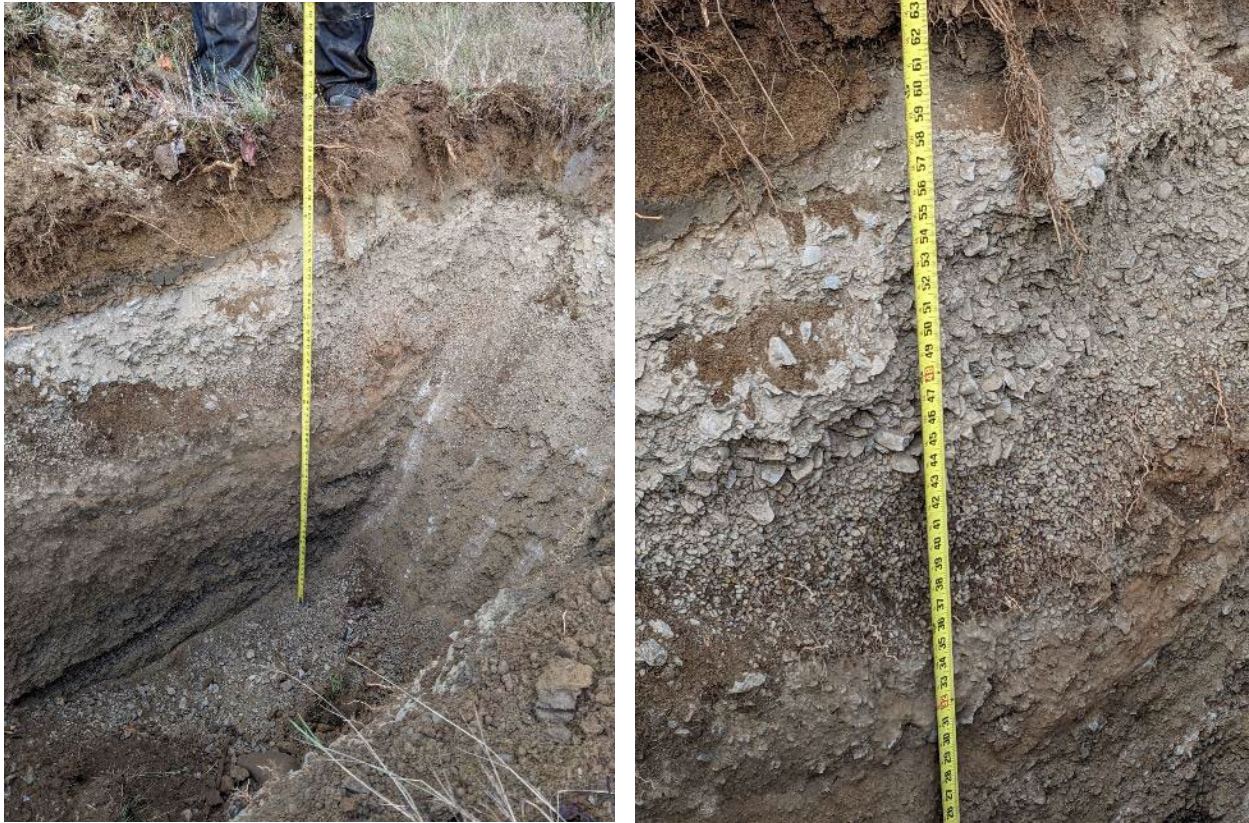
26-9 Photos

Left - Silty loam with crushed rock and pea gravel throughout pit; Right - close up of crushed rock layer at 1.25 feet

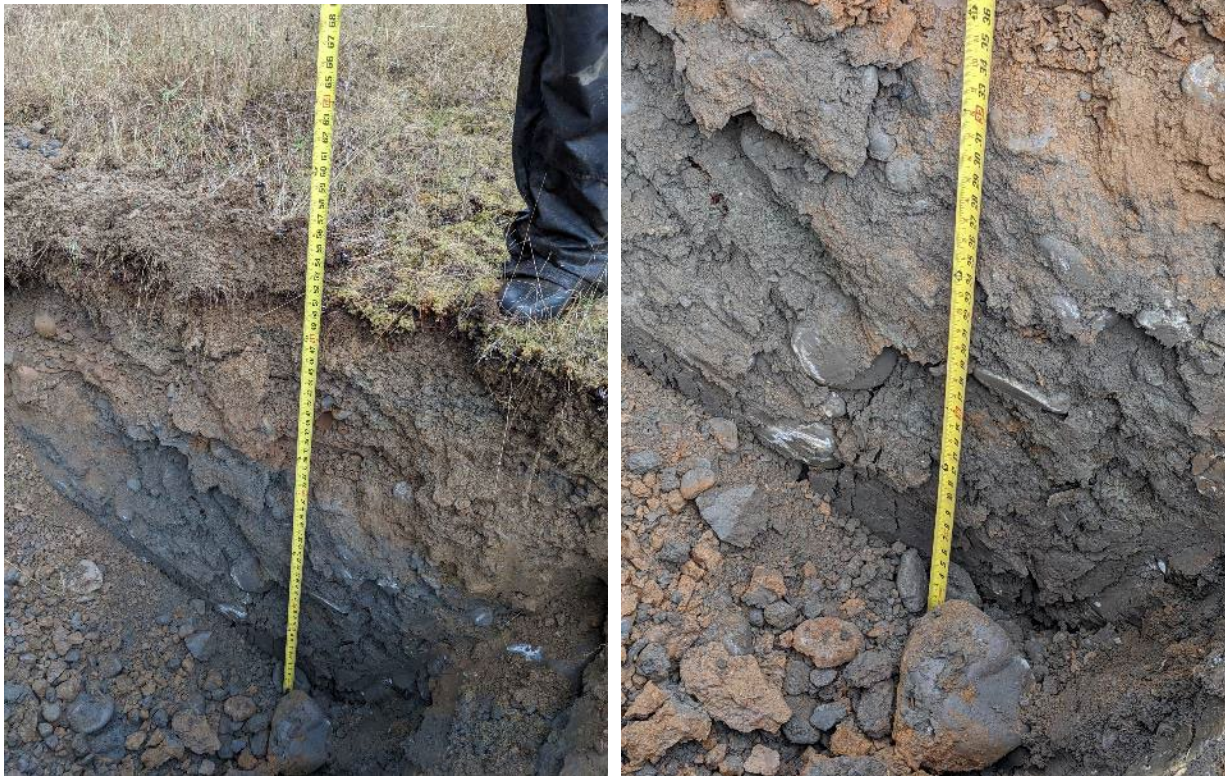
26-11 Photos

Top - Brown sandy loam above grey sandy loam with gravels and small cobbles; Bottom - close up of grey silty sand with approximately 30% cobbles

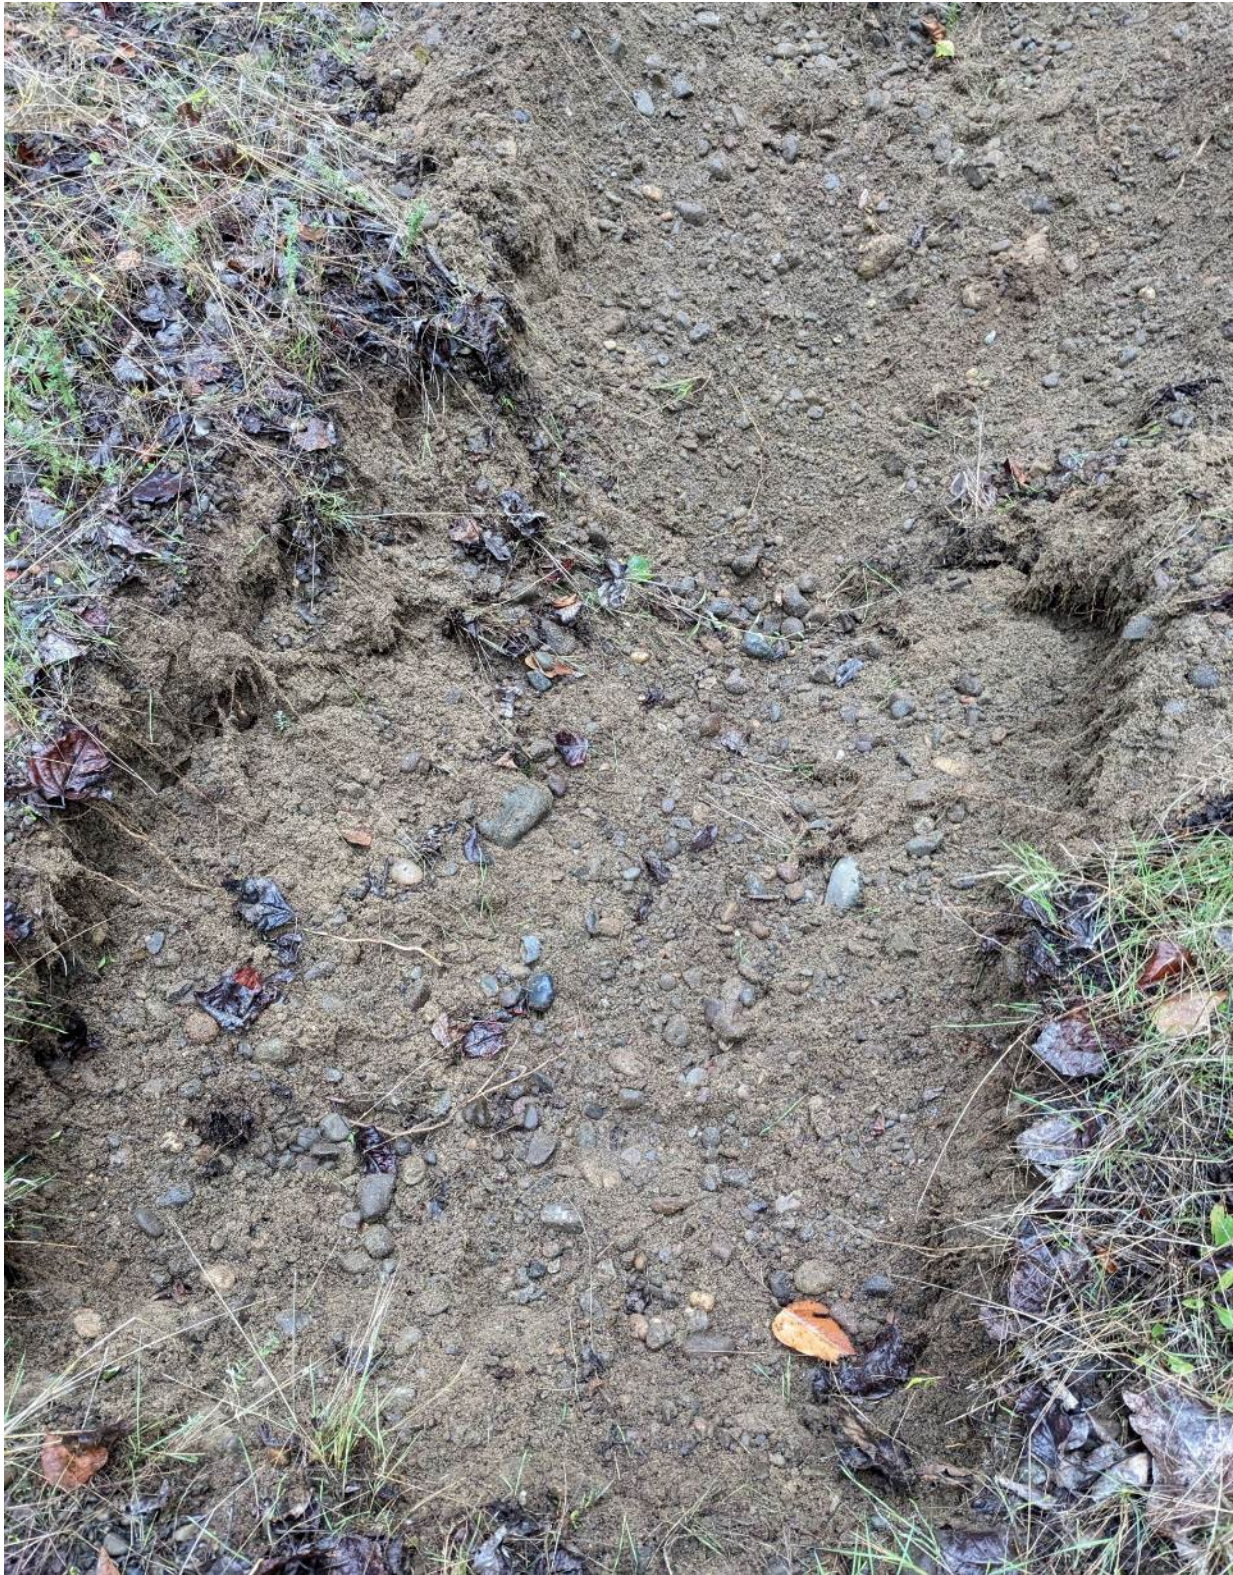
27-2 Photos

Above - Pit with brown sand with gravels and cobbles to 4 inches

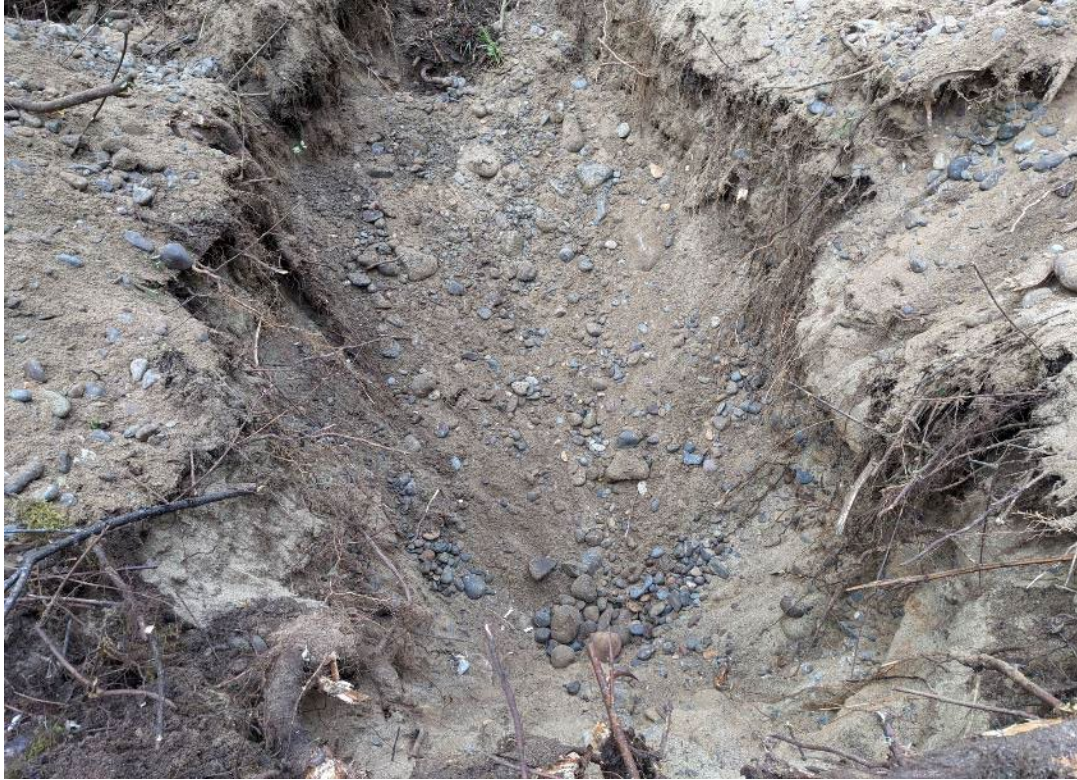
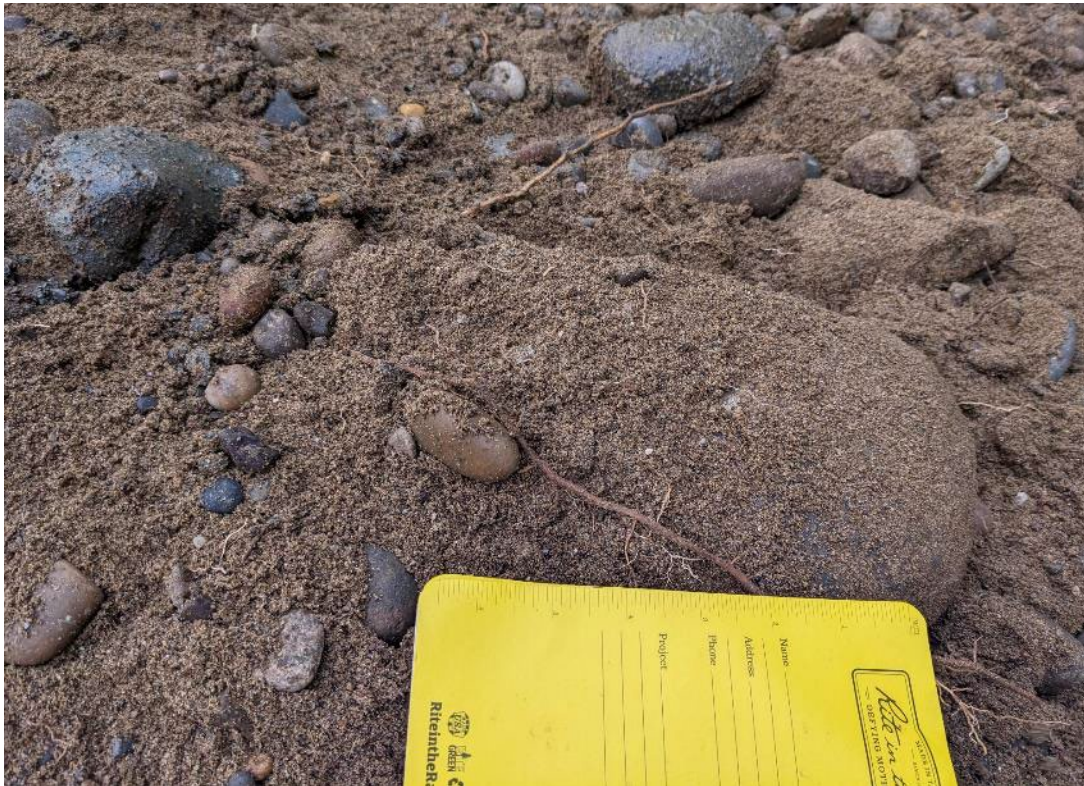
27-3 Photos

Top - Top 6 inches with thick roots, brown sandy loam; Bottom - close up of gravels and cobbles at 5 feet

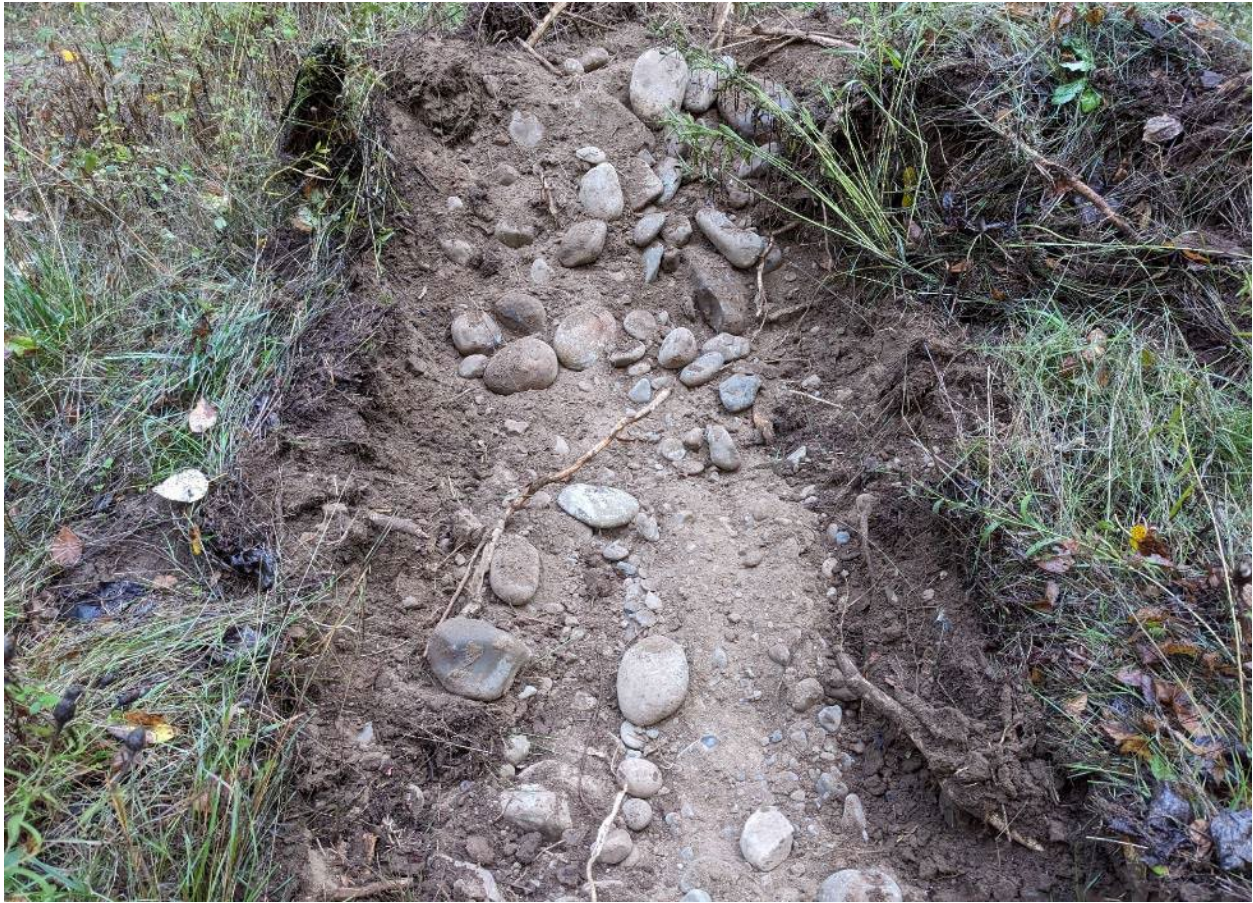
27-4 Photos

Above - Shallow pit to 10 inches, cobbles start at 4 inches

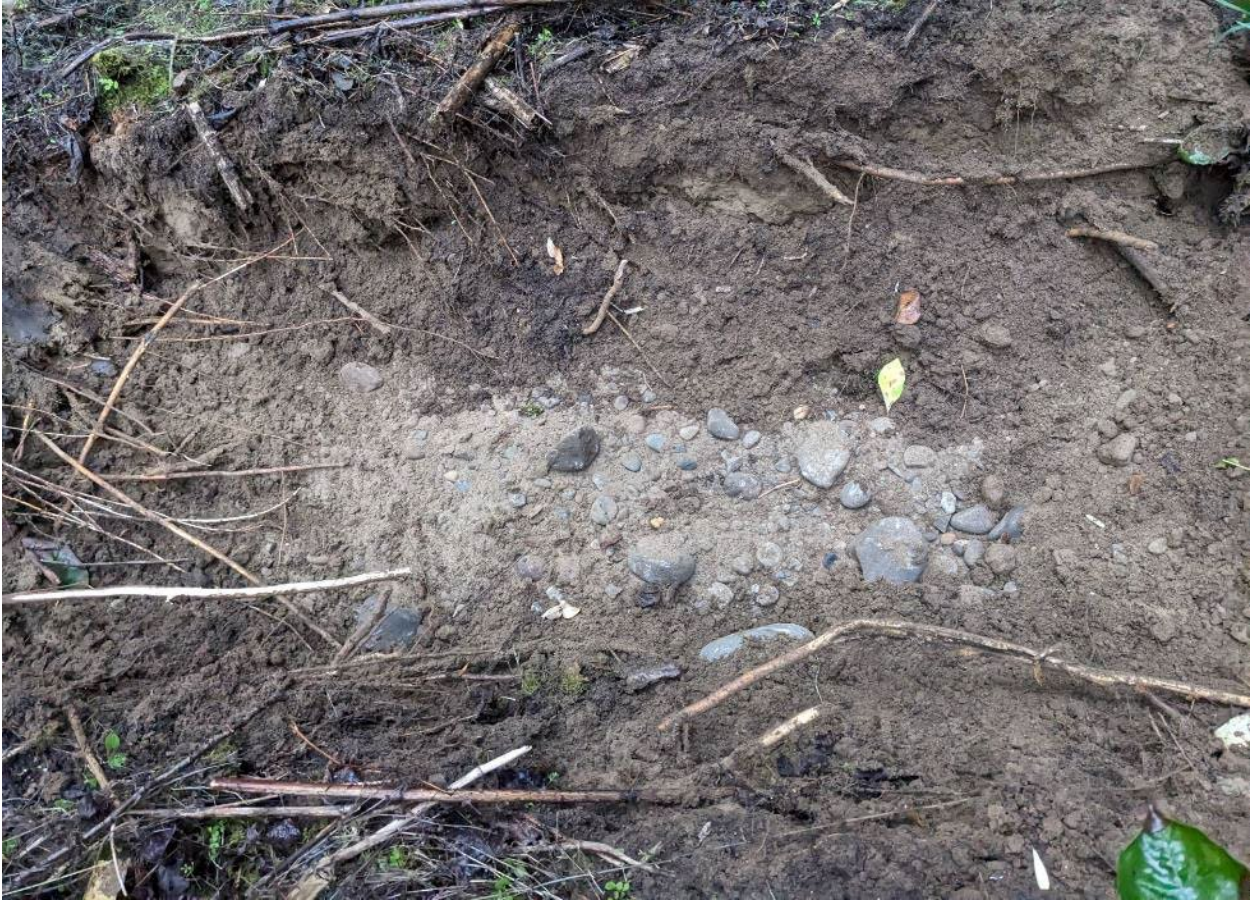
27-5 Photos

Above - Cobbles and gravels start at 18 inches

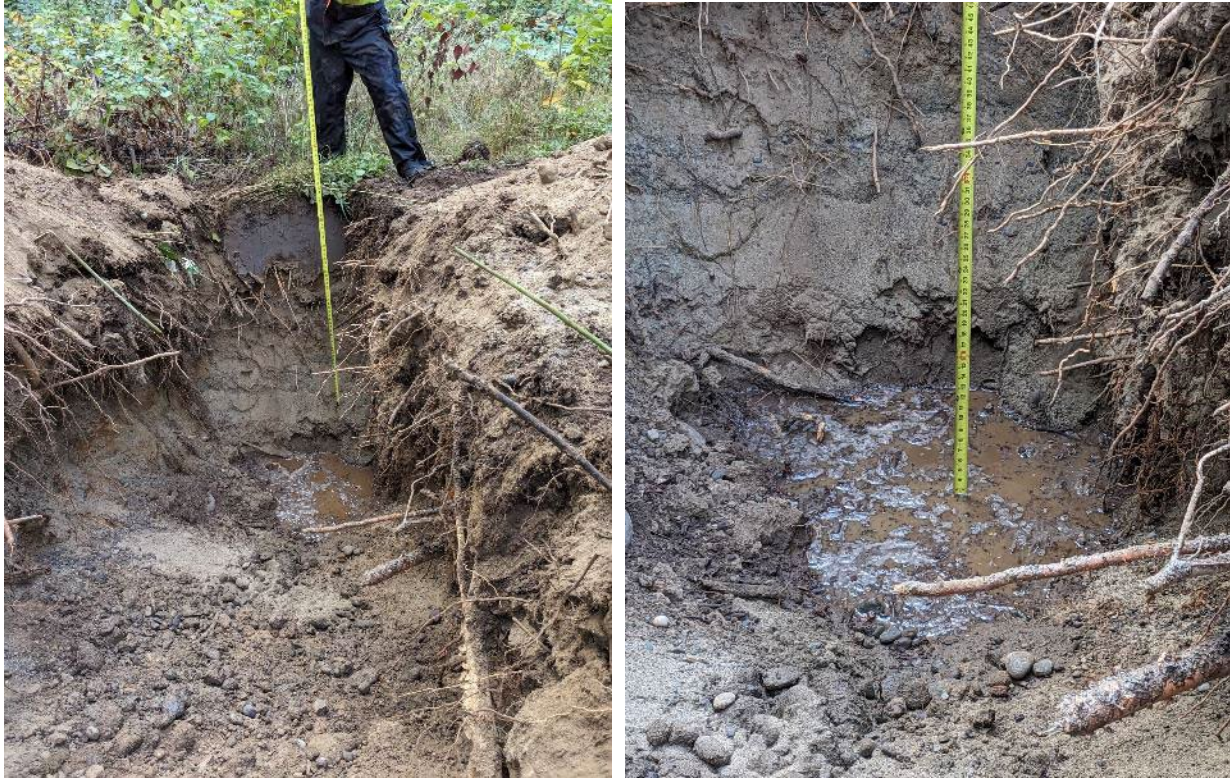
27-6 Photos

Left - Pit with thick roots at top, silty sand; Right - Close up of groundwater at approximately 6 feet, pit caving in at 6 feet

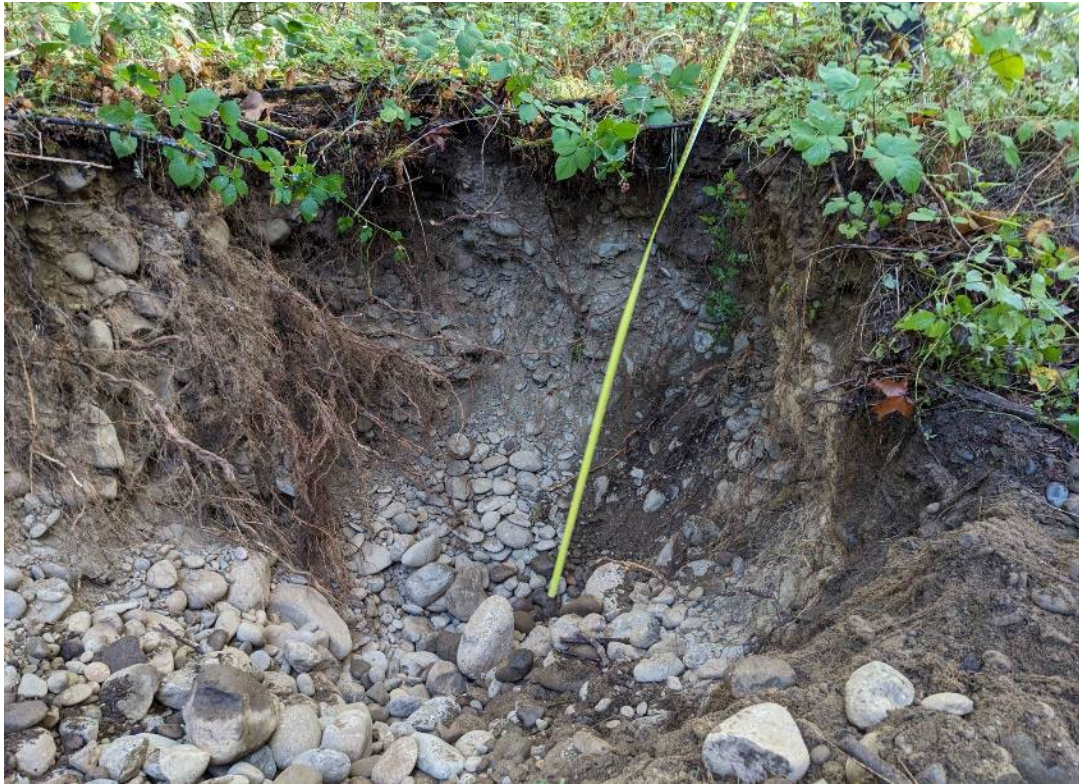
27-7 Photos

Top - Pit taken in berm, gravels and cobbles at surface, larger cobbles at 6-7 feet; Bottom - close up of cobbles and gravels from bottom of pit

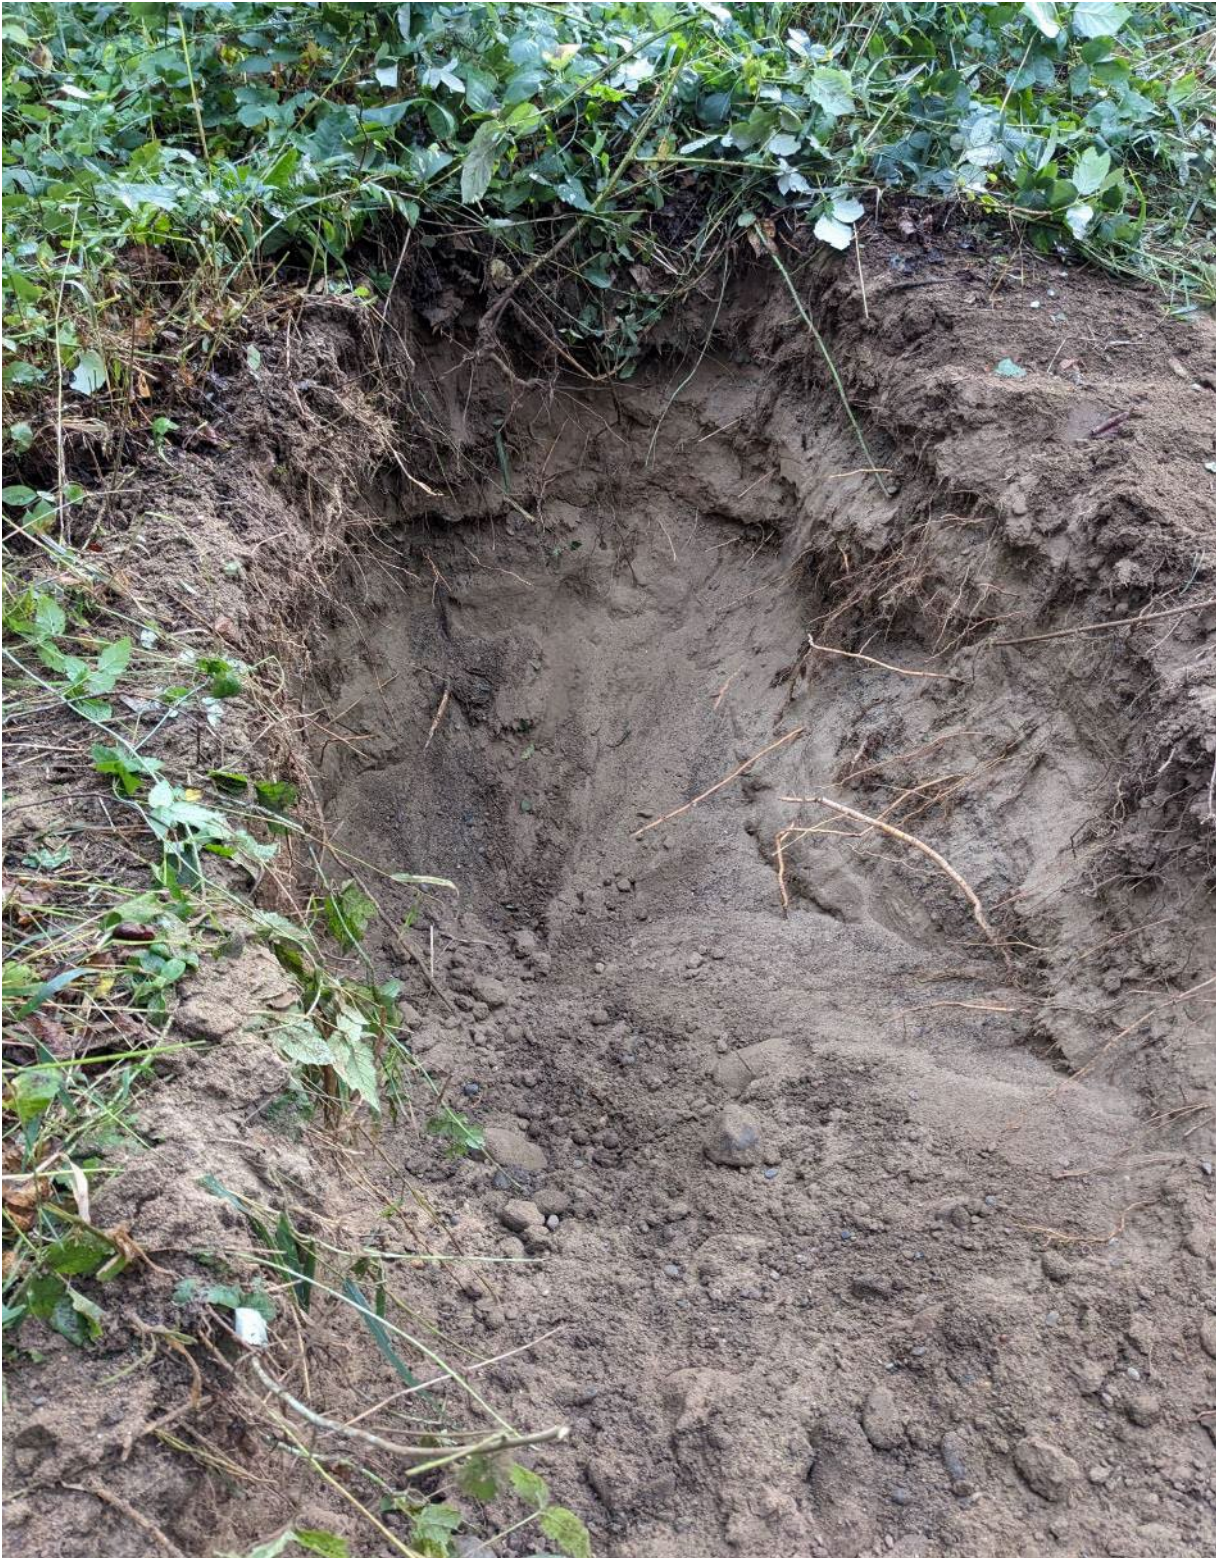
27-8 Photos

Above - Brown sand with a few cobbles at bottom of pit

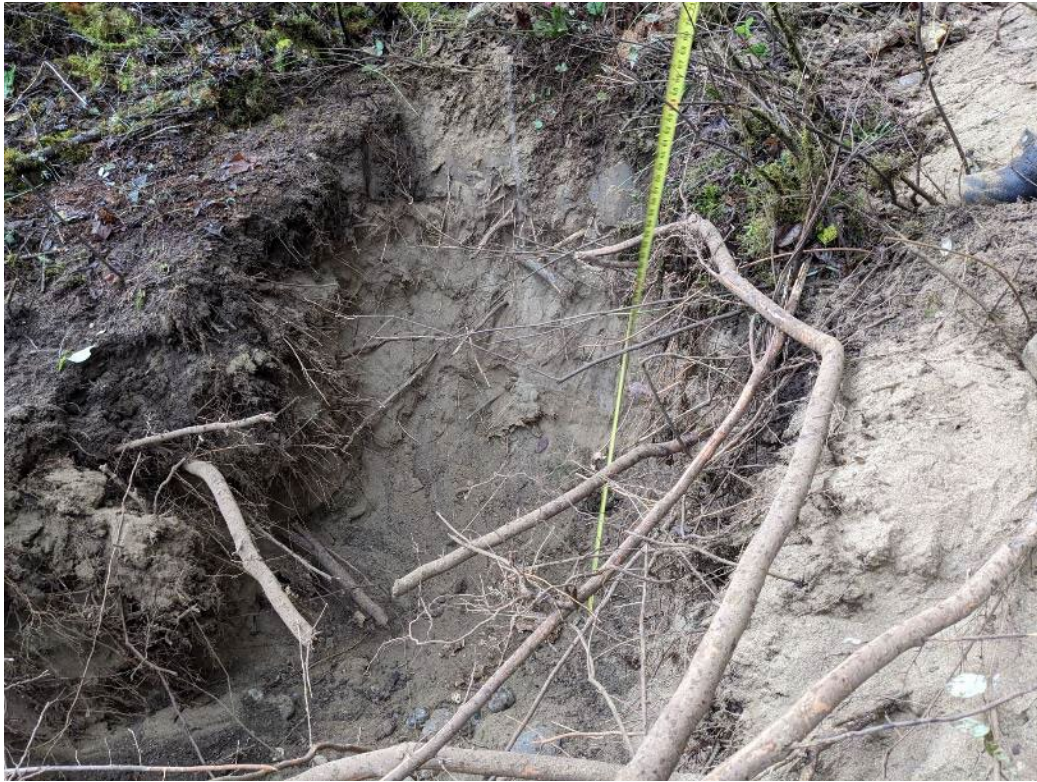
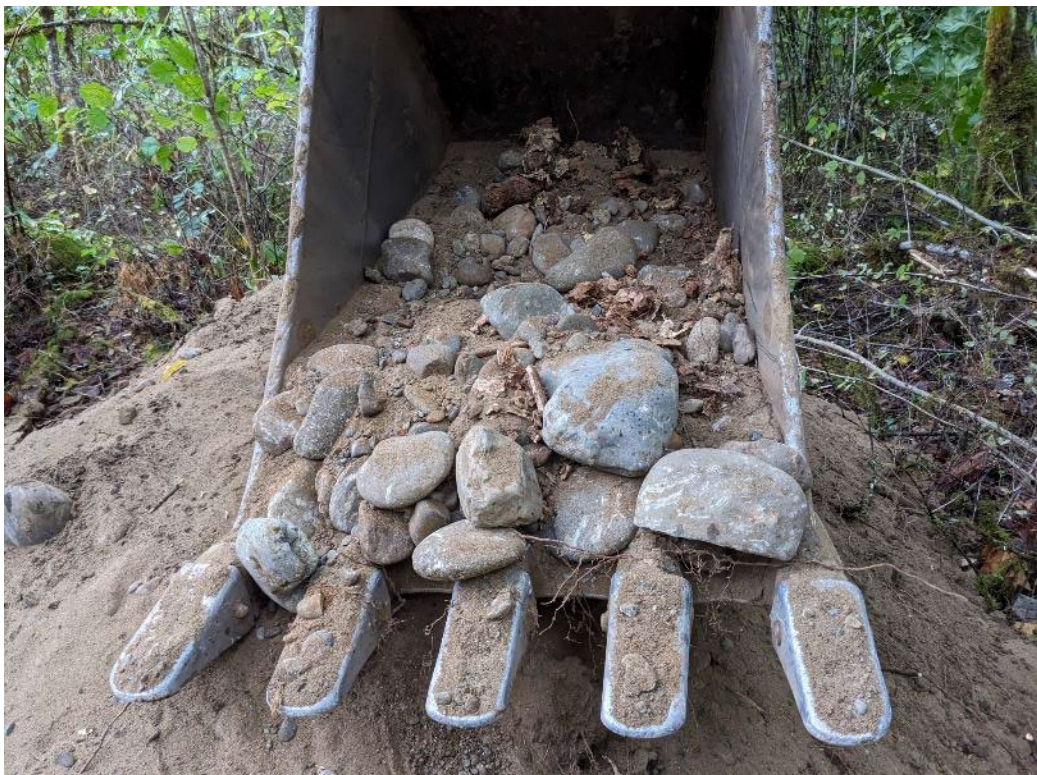
27-9 Photos

Top - Thick roots at top of pit, mostly sand and sandy loam; Bottom - close up of sand with cobbles at bottom of pit, cobbles up to 12 inches

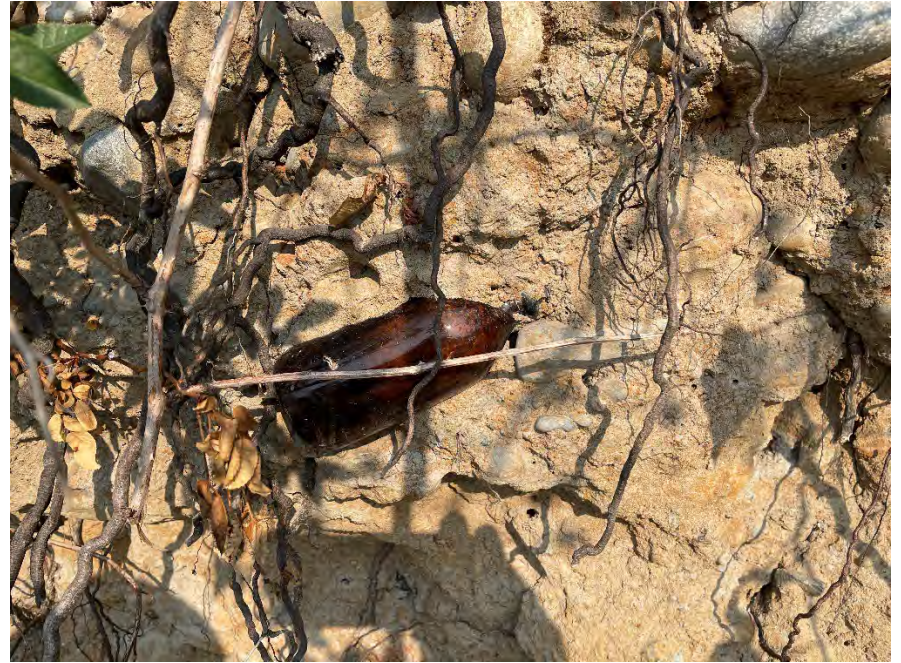
Bottle (dated approximately 1957) found buried a few feet below the surface near here.

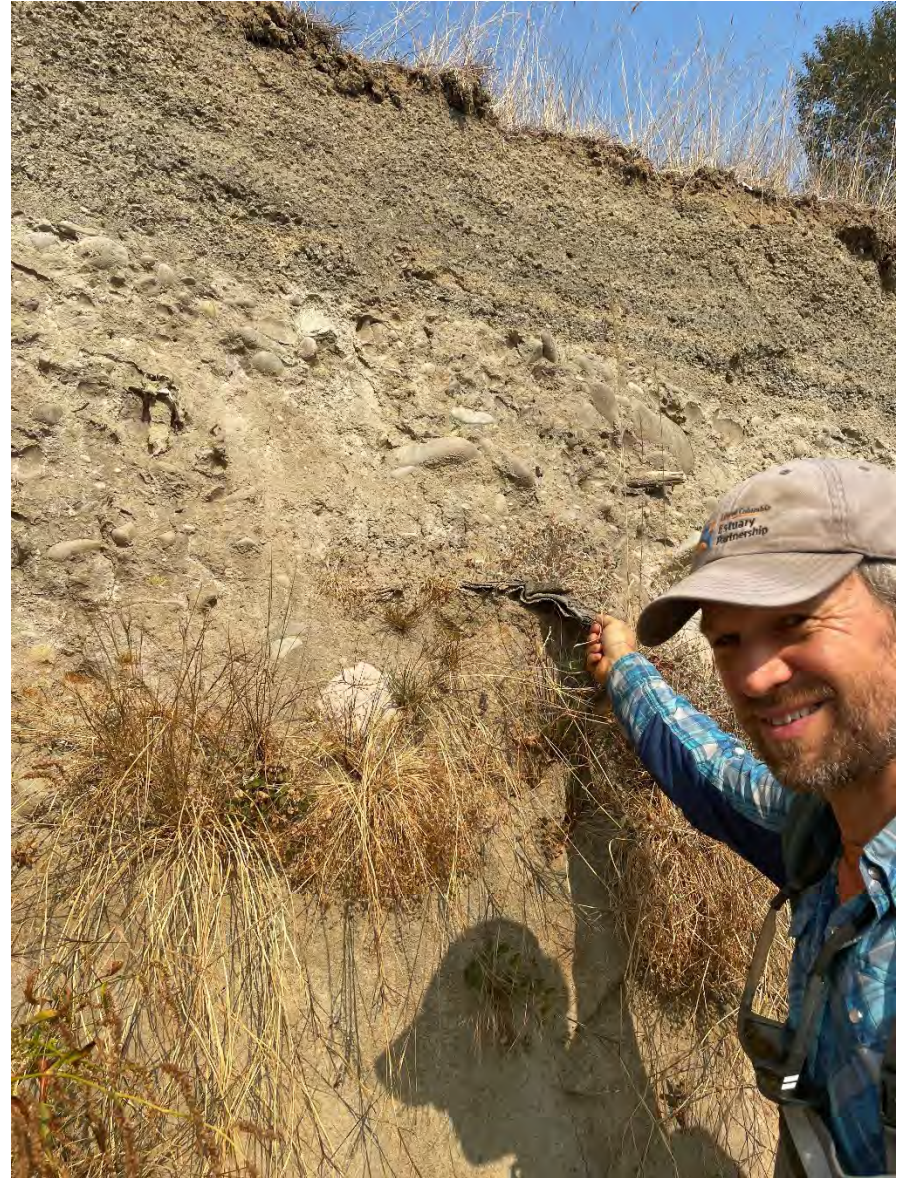
Bank Exposure – Site F

Zoomed in photo of upper portion of bank showing buried foreign material located at approximately 2 feet depth.
